Modern and historic earth buildings: Observations of the 4th September 2010 Darfield earthquake

ABSTRACT: The New Zealand Earth Building Standards published in 1998 are very comprehensive and gain considerable attention internationally. The Darfield earthquake is the first time that the NZ reinforcing approach has been tested in the field. Ten modern style houses using rammed earth, adobe, pressed earth brick, and poured earth technologies were surveyed in October 2010. Where good reinforcement and design was applied the minor damage was due to differential ground movement, very high walls, or inadequate detailing. Subsequent to the 22nd February 2011 earthquake a further survey identified shaking damage to pressed earth brick houses which require better detailing. Four unreinforced historic, or reconstructed, cob and sod cottages and three historic cob houses were investigated. Two cottages with earth walls from the 1860's were the most severely damaged, reconstruction needs to preserve the original material components.

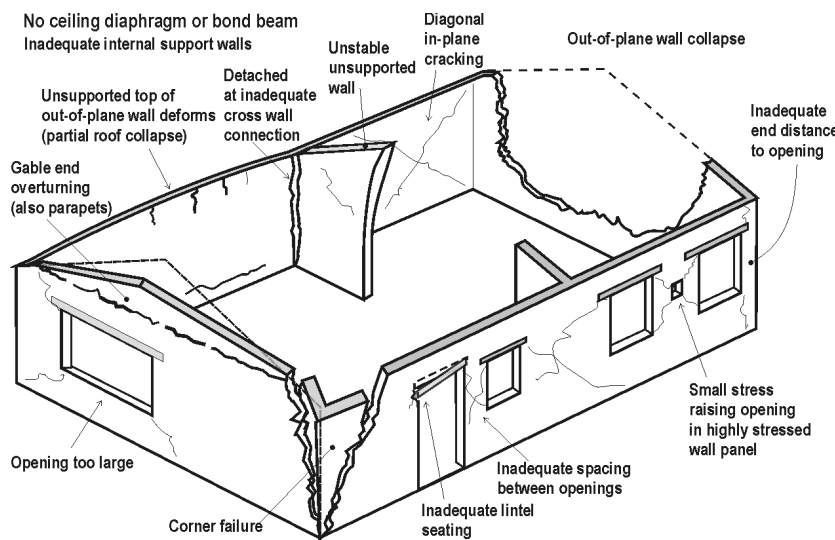
Earth buildings that are unreinforced have a number of typical failure modes as illustrated in Figure 1. These modes of failure were observed in two reconstructed historic cottages. Serious damage to Cotons Cottage in Hororata is shown in Figure 2, the horizontal peak ground acceleration (PGA) measured 0.5g just 350m away. Horizontal accelerations (PGA) through this paper are from GNS data interpolated from the NZSEE bulletin (Gledhill et al. 2010, Cousins and McVerry 2010). It is proposed that this building be reconstructed using the same soils and historic techniques but with steel and polysynthetic geogrid reinforcing within the wall fabric.

Figure 1 Typical failures of unreinforced earth construction

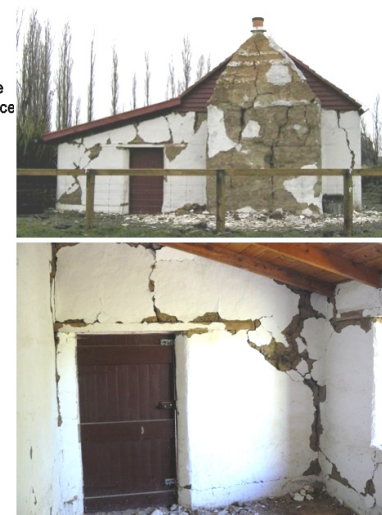
Figure 2 Cotons cob cottage extensively damaged

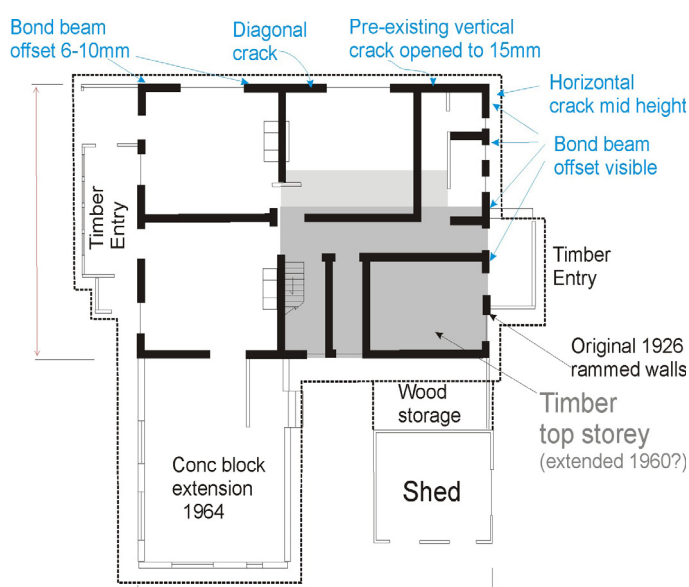
Figure 4 Hororata rammed earth house plan, rammed earth walls are heavy lines, showing damage locations.

The house is located 14km from the Epicentre in the highest horizontal ground acceleration zone directly between two strong motion seismographs and would have been subjected to 0.65g horizontal PGA and 120cm/s peak velocity. The brick chimneys collapsed and furniture was overturned but the walls performed well. The major disrupting feature was the bond beam that shifted to the North West by 6-10mm. The most significant earthquake damage was at a point where part of a wall panel adjacent to a window remained attached to the bond beam noted as a diagonal crack on figure 4.

Most of the damage to this house would have been prevented if there was a positive connection from the wall to the bond beam. The wall thickness is greater than would be required by the earth building standards which would require vertical reinforcement at the ends of each panel as a minimum in moderate or high seismic zones.

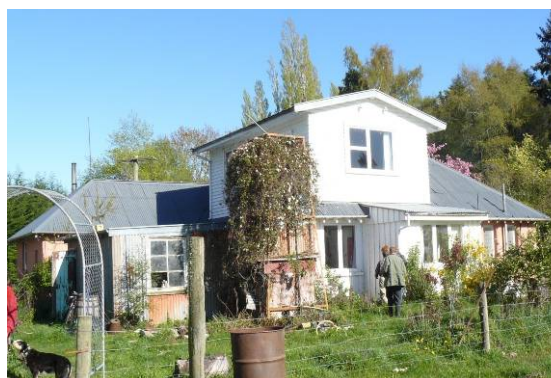
Figure 5 Hororata house, rammed earth on lower right

the reinforcement details are not known but there was no apparent key to the wall. As shown in Figure 4 and Figure 5 the house had a small upper level above the east entry at the time of construction, this was extended in the 1960's and a reinforced concrete block extension added. The slip of the bond beam relative to the north wall can be seen in Figure 6 and in Figure 7 some cracks are shown at the base of that wall

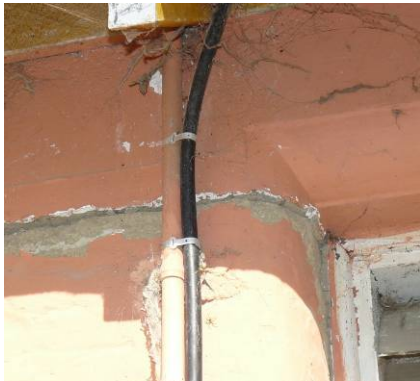
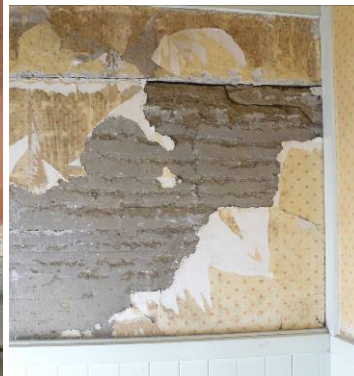
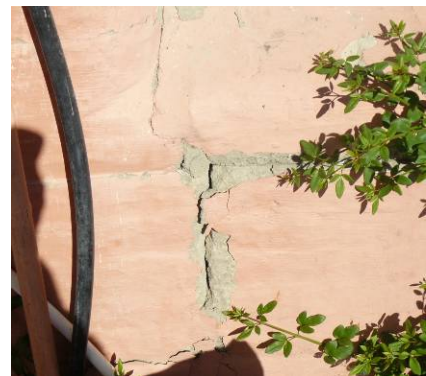
Figure 6 Hororata house showing offset of the bond beam outside and inside and a related wall crack

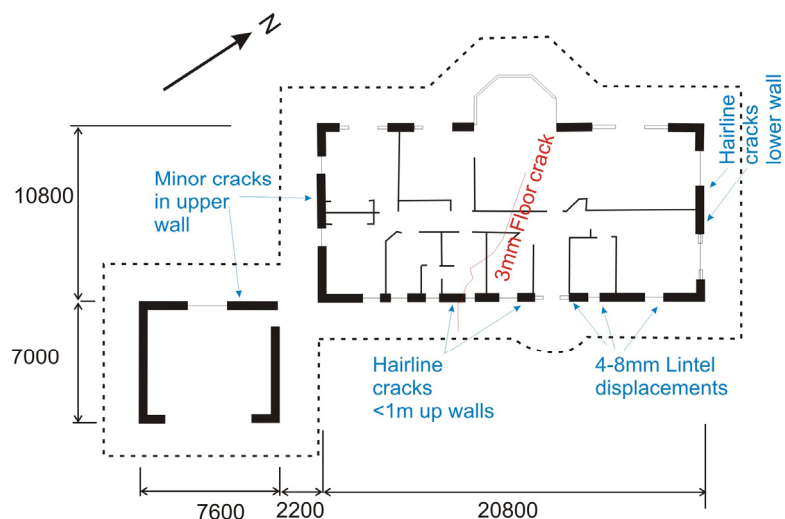
Figure 8 Charing Cross adobe house plan showing adobe walls and minor damage locations

tiles. This crack continued as a 1mm crack through the concrete foundation beam reinforced with a D16 (deformed 16mm rod) top and bottom (two D16 reinforcing rods top and bottom are specified in NZS4299). There were also hairline cracks at foundation level as shown in Figure 8. It appears that there was some differential movement at the west corner where settlement and movement of the verandah posts embedded in the concrete path caused cracking in the upper south wall (Figure 10). Lateral movement had caused movement or minor pounding of the lintels leaving gaps of 4-6mm at ends of the lintels (Figure 11).

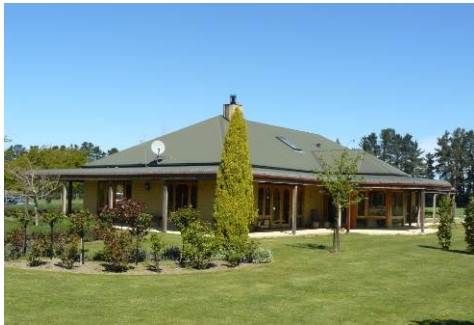
The adobe house illustrated in Figure 8 and 9 was built in 1997, 4km from the epicentre. It was 800m from the fault trace towards the epicentre and 6km from the Greendale seismometer so is likely to have experienced 0.7g to 0.8g horizontal PGA. The walls are 275 mm thick and 2.7m high and are horizontally and vertically reinforced. Vertical reinforcing is continuous to the top plate which is additionally anchored to both the wall and the ceiling diaphragm. The most significant damage was a cracked floor slab evident from a 2-3mm crack in the floor

The Charing Cross house incorporated many details that are included in the earth building standards but with a slightly weaker diaphragm and no rigid cross walls. The primary damage was due to differential ground movement and while the cracking indicated that the building had suffered significant shaking the limited amount of damage in this significant event provides some evidence for the effectiveness of the building system.

Figure 9 Charing Cross adobe house, 4km South East of the epicentre

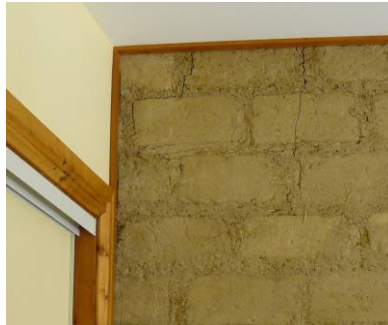
Figure 10 Crack in wall near the west corner

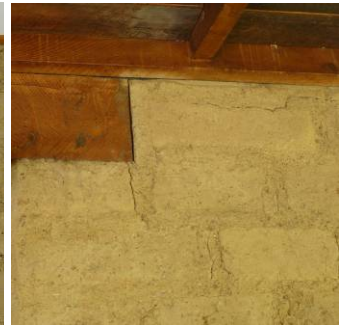
Figure 11 Opening at edge of lintel beam

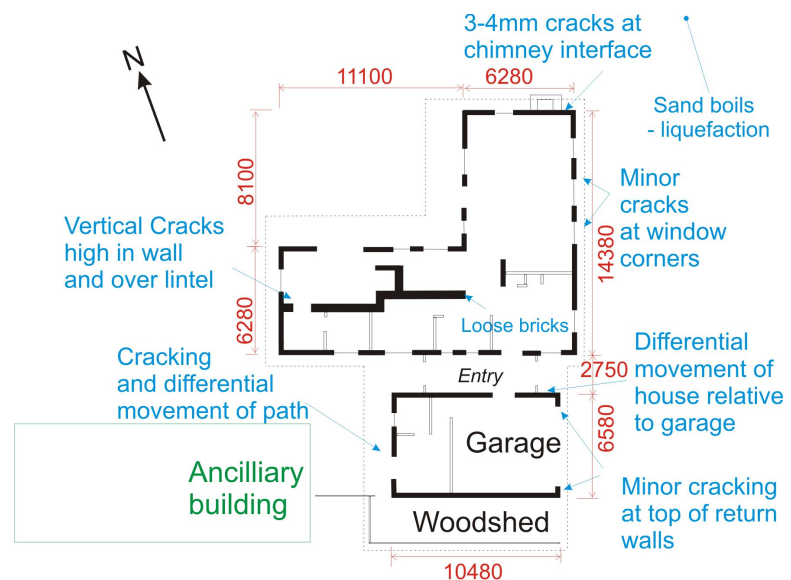
Figure 12 Leeston adobe house plan showing locations of damage

Most of the damage is shown in Figure 12, it was clear that differential ground movement had separated the garage from the house. The return walls at the garage entry were too short and there was some dislocation of upper level bricks. The most obvious damage was due to the differential movement of the chimney (Figure 13). This is not structurally significant but will require a difficult repair. There were minor cracks that extended for several brick depths below several windows as shown in Figure 14. The high wall had several bricks at the top that were insufficiently anchored into the top beam and cracked with some becoming loose.

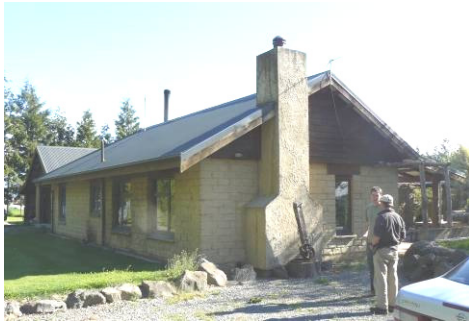
Figure 13 Leeston adobe house showing chimney

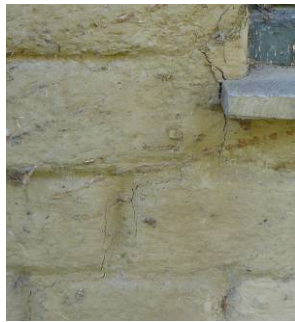
Figure 14 Typical cracks adjacent to window

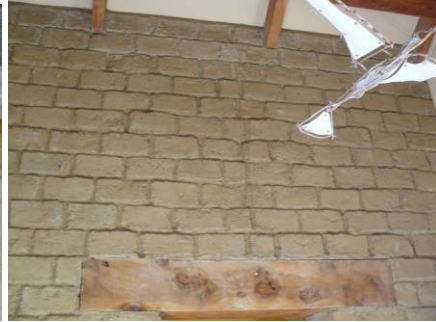
The most significant damage was a vertical crack in the high wall above the lintel beam, the 2m of wall above the opening had moved out-of-plane during the earthquake (Figure 15). This unusual feature would require more specific reinforcement detailing if it were to be formally designed.

The majority of damage to the house was minor and differential movement of the chimney and garage was clearly made worse by the poor foundation conditions. The tall wall did satisfy the height to thickness requirements of the NZS 4297 Engineering Design standard but is well outside the scope of NZS4299 and is not recommended in high seismic zones.

Figure 15 High wall above lintel (vertical crack not visible)

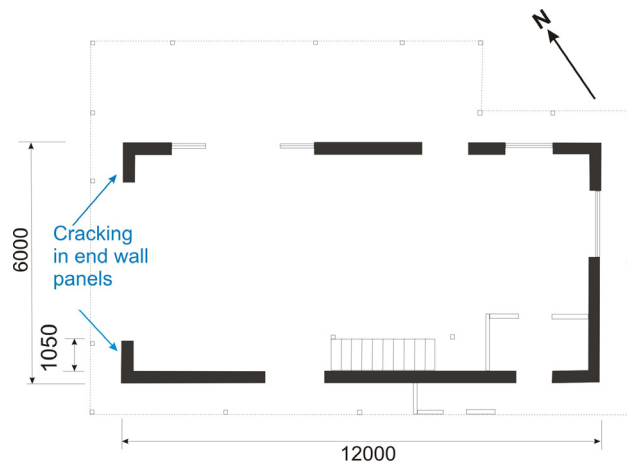
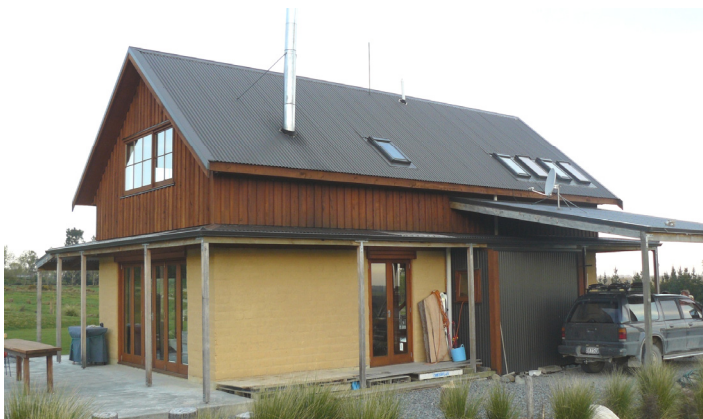
This house has lower storey adobe walls with a thickness of 280mm and 2.4m high, it was built in 2008. It is 60km from the epicentre on shallow soil and subjected to about 0.15g-0.2g horizontal PGA and MMVI. It has a timber upper storey and had some design input to comply with aspects of the Standards but does not comply with NZS 4299 in terms of cross walls and had very short return walls as shown in Figure 16 and Figure 17.

Figure 16 Staveley adobe house – lower level plan

Figure 17 Staveley house lower walls adobe

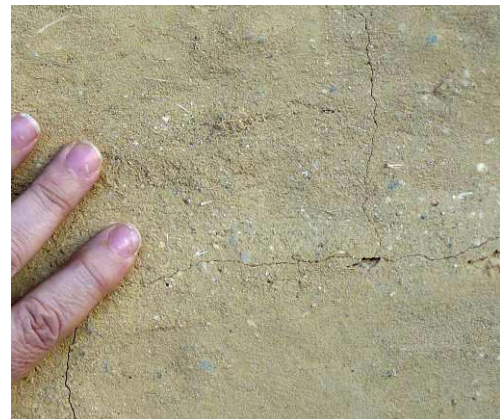
The house was maintained to a high standard but the lateral movement during strong wind was reported by the owners to be significant at the NW end of the house. Cracks were identified through the full wall thickness following the moderate to strong shaking (Figure 18). Preliminary evaluation indicated that the bond of the brickwork had failed in the very short return walls, because there were no other internal return walls and the reinforcement was discontinuous and only tied with wire ties. If the details in the Non-Specific Design standards had been followed this would not have occurred.

Figure 18 Cracking through plaster showing fractures at mortar joints

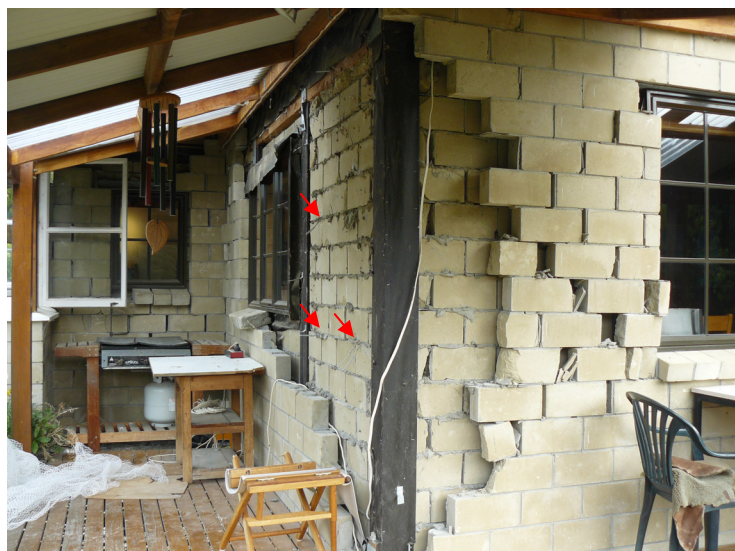
Two houses had a light timber post and beam structure with infill pressed earth (Cinva) brick walls and experienced strong shaking (estimated MM VI). The walls comprised double skin 100 mm thick pressed bricks laid on their edge with a 50 mm cavity with metal ties across the cavity as shown in figure 19. Major failures of the walls occurred for both these houses with significant collapse of the outer skin and some drop outs of bricks from the inner skin. The timber structure in both cases remained intact and the houses did not collapse. However the overall wall bracing in both houses was compromised by the collapse of these walls and both houses will require substantial repairs and strengthening.

Figure 19 Little River post and beam house with pressed brick infill walls. Lower storey shows a post and damaged exterior double skin cavity walls with some remaining pulled out ties between wythes indicated.

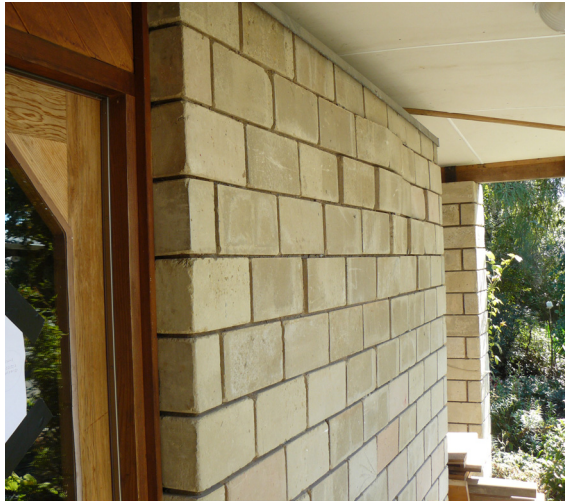
The damage to the second single storey post and beam pressed brick house is shown in figures 20 and 21 showing double skin pressed earth walls that were significantly damaged and in danger of collapse.

Figure 20 Burwood single storey post and beam house with pressed brick walls showing upper level damage

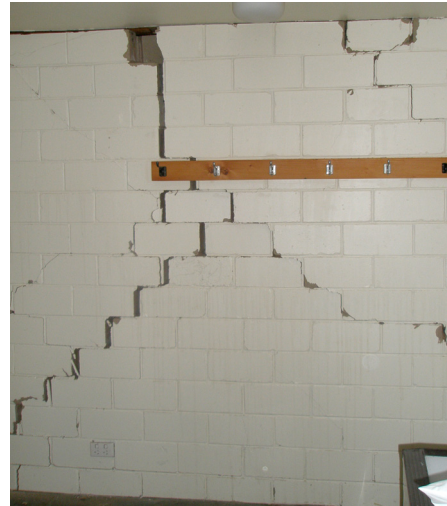
Figure 21 Burwood house internal infill double skin cavity wall showing major damage.
