## **SUMMARY OF COB DAMAGE EXPECTATIONS 2010 & 2011 NEW ZEALAND EARTHQUAKES**

The damage was consistent with expectations and would have been prevented if the details used were consistent with the New Zealand earth building standards. Illustrated here are photos of two of the damaged cob houses and a drawing of how unreinforced cob buildings can be expected to fail in a severe earthquake.

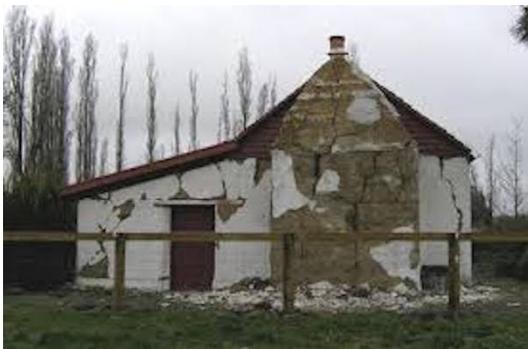
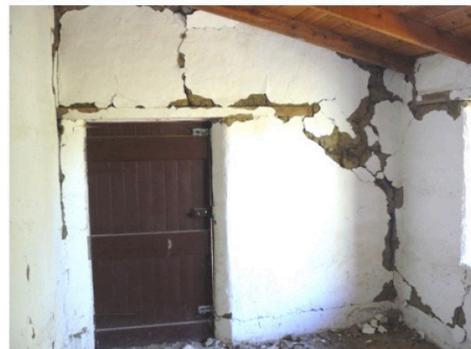
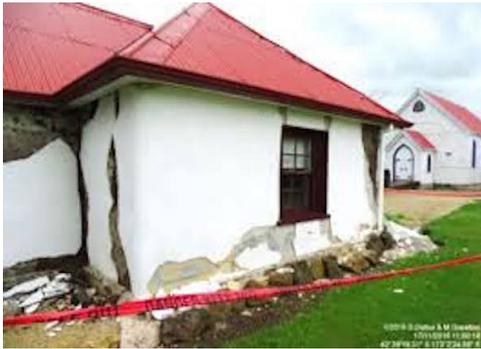
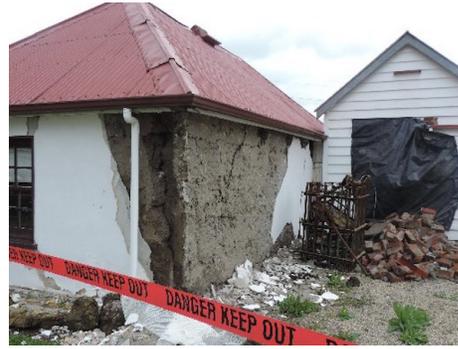
On September 4th, 2010, Darfield, New Zealand (near Christchurch) experienced a 10 km deep, 7.1 magnitude earthquake. This was followed on February 22nd, 2011 by a 6.3 magnitude earthquake near Lyttelton (also near Christchurch). There were 32 earth houses and cottages, and 10 sheds or utility earth buildings in the affected areas. Subsequently 15 of these buildings were surveyed for damage. These buildings included a range of earth wall types. Built to modern earth construction were: sun dried adobe brick, stabilized rammed earth, stabilized Cinva pressed brick, and cement stabilized poured earth. There were also historic or replica cottages built of un-stabilized cob. Each of these technologies performed well when properly reinforced. The sod and cob constructions were unreinforced and some suffered major damage.

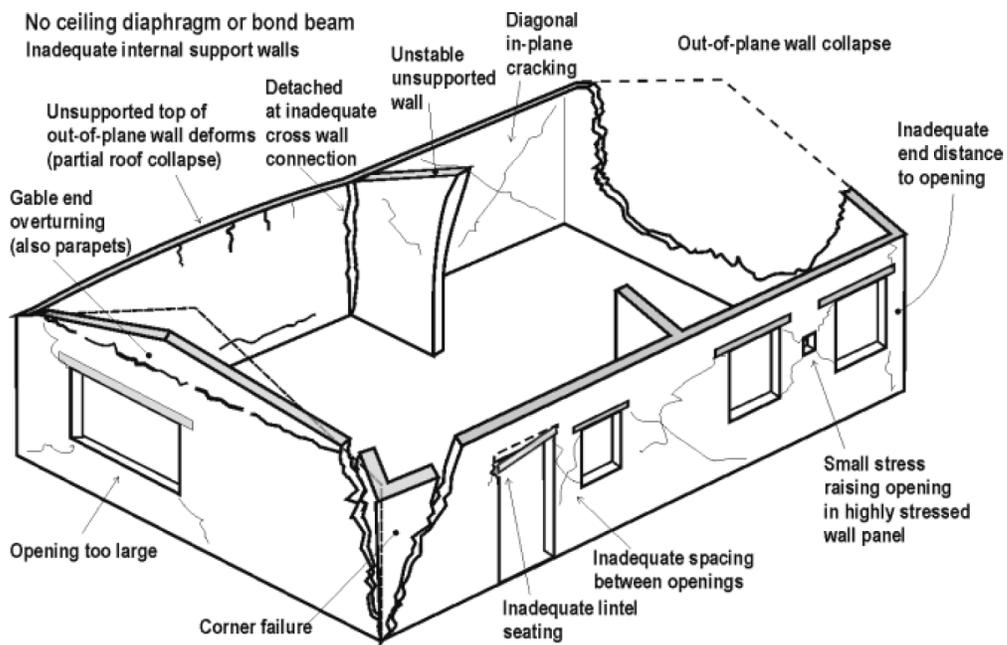
*Figure 2: Typical earthquake damage in unreinforced houses. © Morris*
