OBSERVATIONS OF THE PERFORMANCE OF EARTH BUILDINGS FOLLOWING THE FEBRUARY 2011 CHRISTCHURCH EARTHQUAKE

Hugh Morris¹ and Richard Walker²

SUMMARY

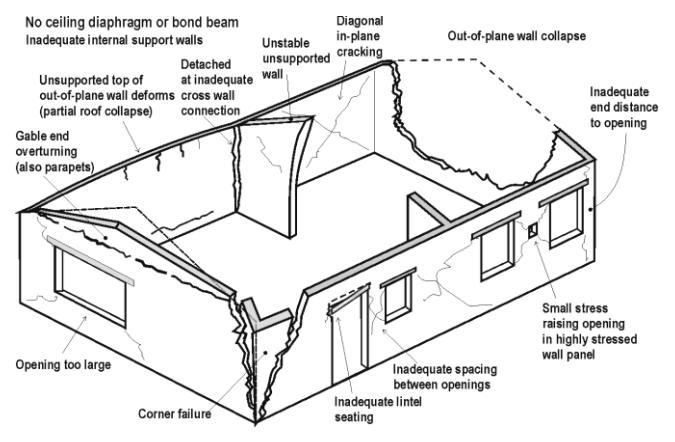
Figure 2: Typical earthquake damage in unreinforced houses. © Morris

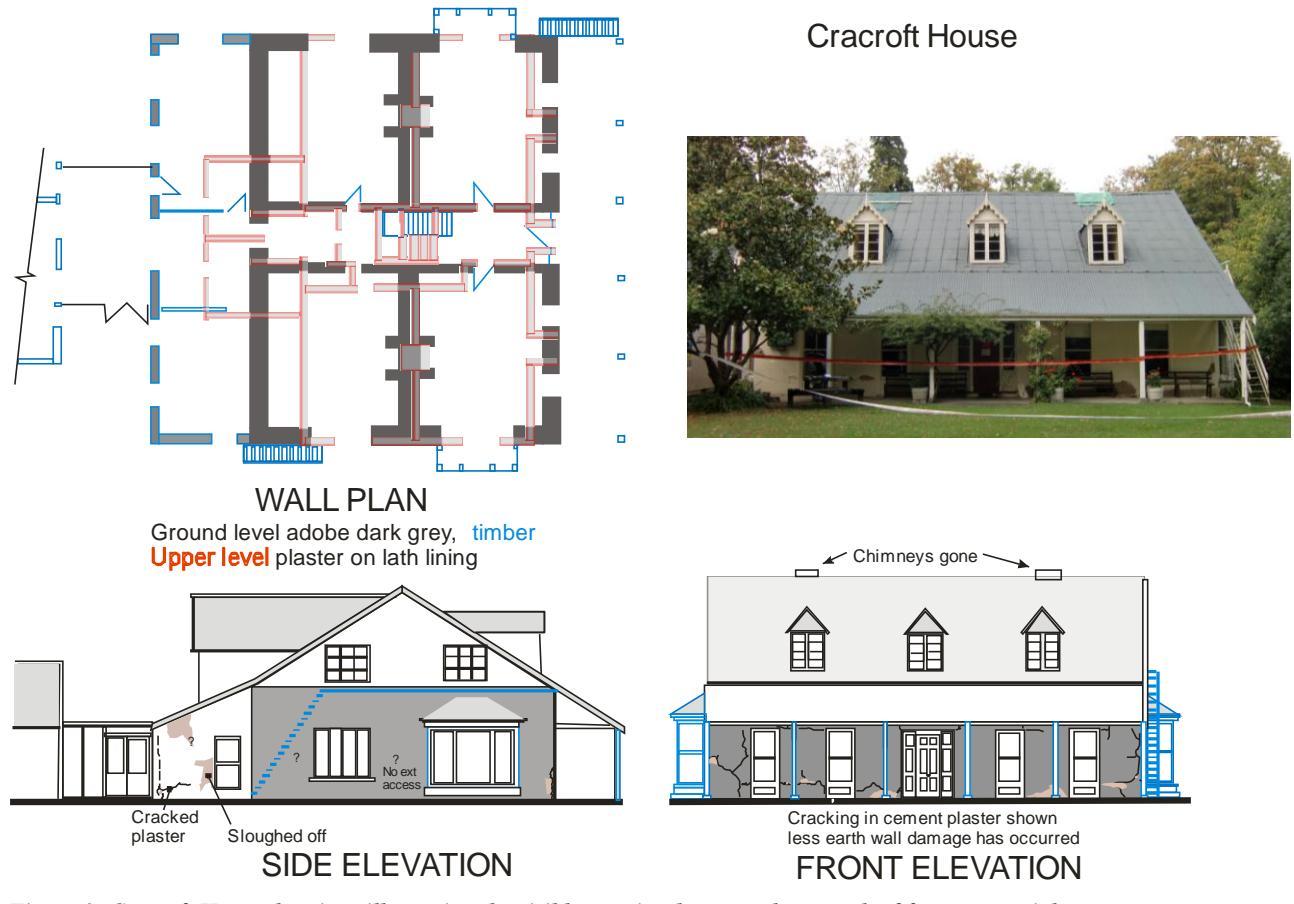
Figure 3: Cracroft House drawings illustrating the visible exterior damage, photograph of front at top right. (Photo G North)

Some of the adobe structure has been repaired with burnt brick and plastered with a cement plaster. The cracking in the plaster indicated significant deformation while the underlying adobe has suffered significant fracture it appeared to be to a lesser extent than the plaster. Figure 3 illustrates the overall house and crack damage, in particular on the front wall.

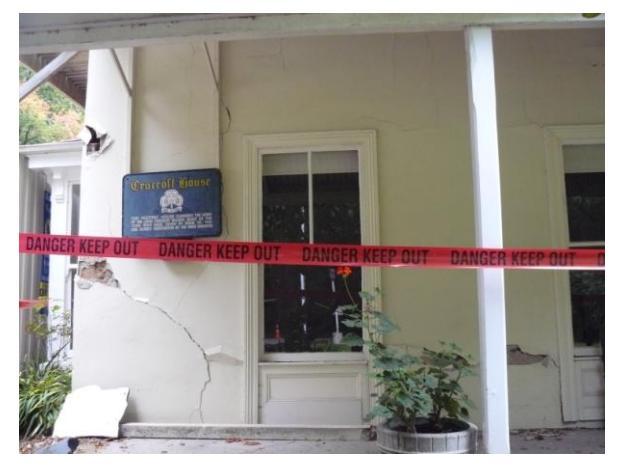
Figure 4: Cracroft House front corner with plaster cracks. The small plaster drop out revealed burnt brick repairs.

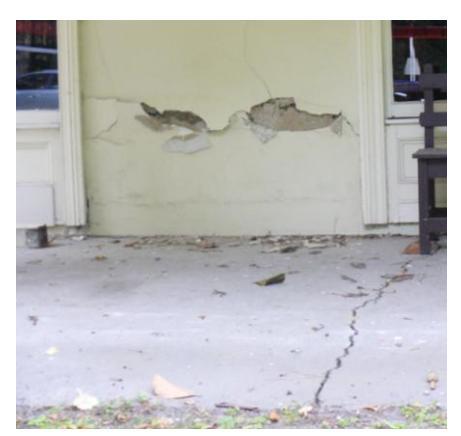
Figure 5: Cracroft House front wall plaster cracks and minor lateral spreading damage to the concrete porch.

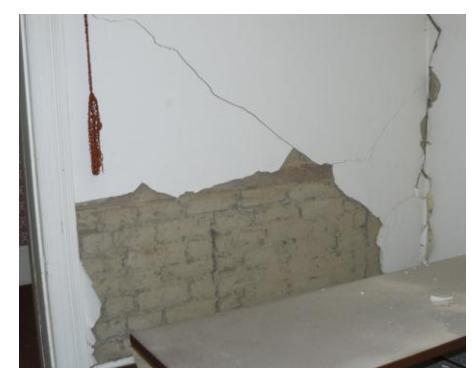
Figure 6: Cracroft House interior plaster with significant damage, underlying adobe wall showing less damage.

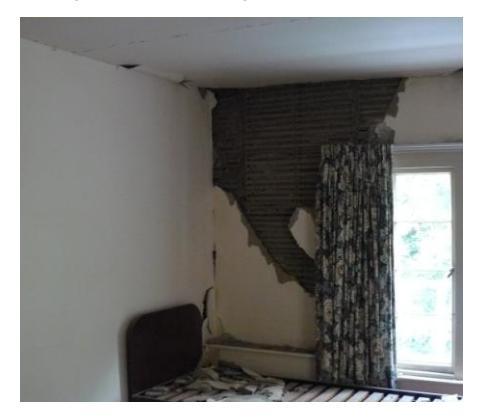
The upper level was light construction with mud plaster on lath for both walls and ceilings. This suffered significant damage as shown in Figure 7.

Figure 7: Cracroft House damage to upper level walls of plaster and lath.

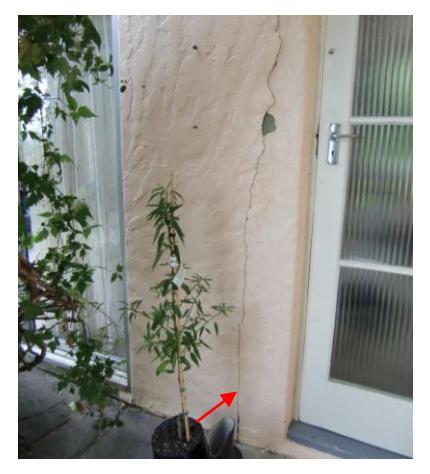
Figure 9: Unreinforced Rammed Earth Kennedy's Bush Road (House 23) showing a minor vertical crack.

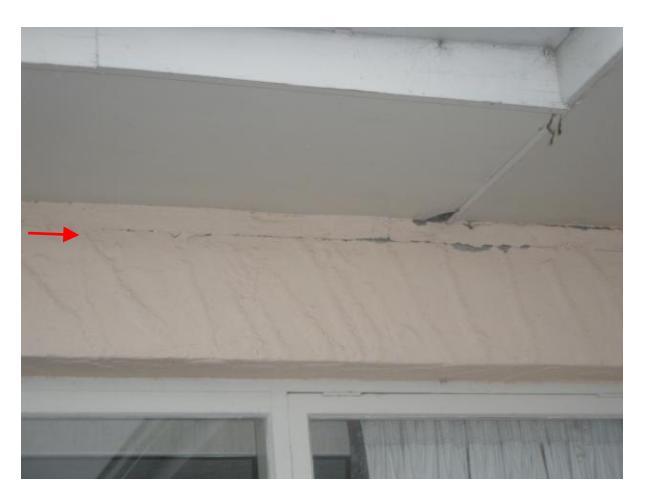
Figure 10: Unreinforced Rammed Earth Kennedy's Bush Road (House 23) showing damage at the bond beam interface over a lintel. (Photo Drupsteen)

House 23 had only suffered moderate shaking of about MM V. Some internal walls were less than 150 mm thickness and additional restraint should be considered.

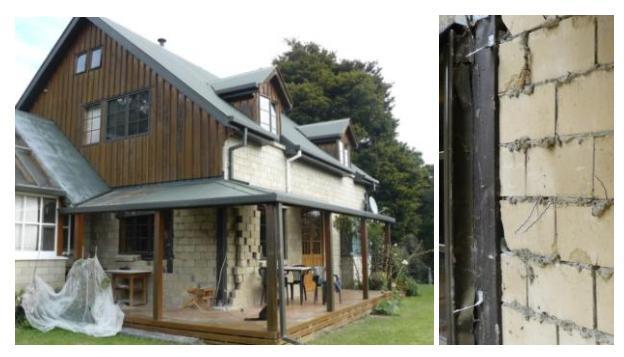
Figure 10: Little River House 17 post and beam construction supporting upper storey, detail view showing ties pulled out of mortar.

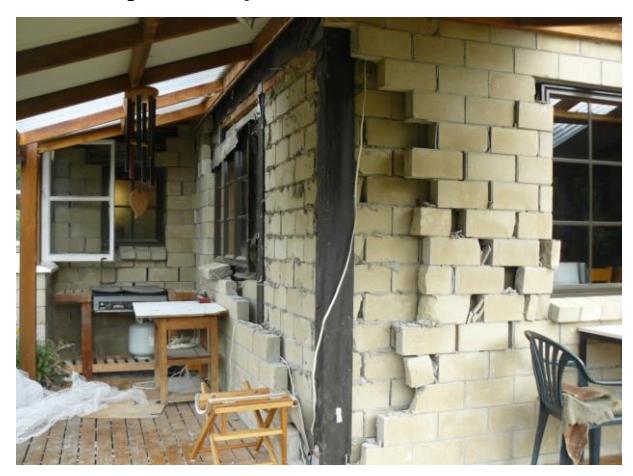
Figure 11: Little River House 17 showing major damage to outer skin of pressed earth brick and significant damage to the inner skin.

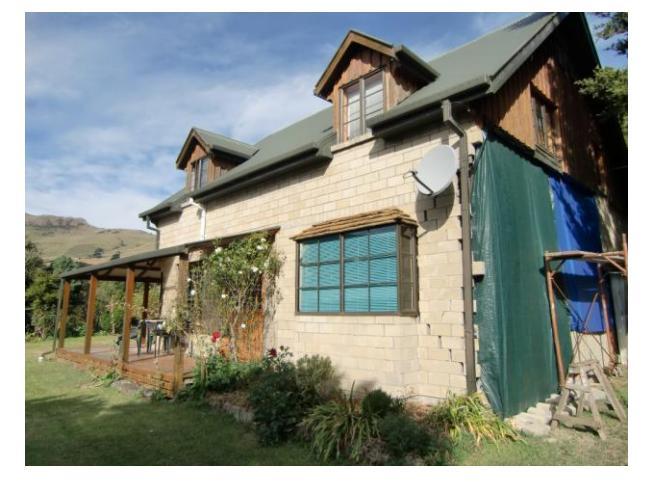
Figure 12: Little River House 17 showing overall house, some minor in-plane cracking and out-of plane failure of the inner and outer skin. (G North)

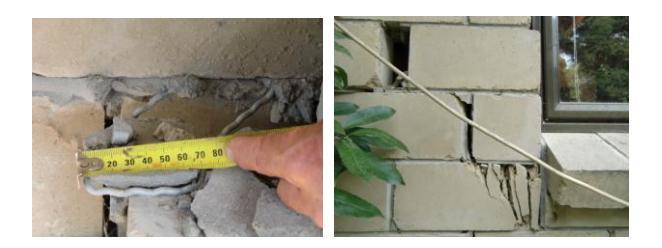
Figure 13: Little River House 17 showing detail of the distorted masonry tie that has failed due to mortar bond. On the right in plane rupture showing mortar failure and crushing of the pressed earth masonry. (G North)

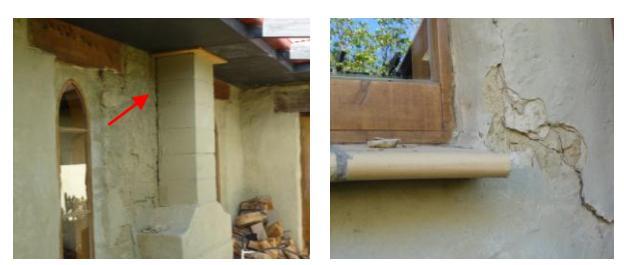
Figure 16: Diamond Harbour reinforced adobe house showing detachment of inadequately reinforced concrete chimney and crack damage at south window.

This adobe house experienced MM VII shaking. The most significant damage was to the concrete chimney (Figure 16) which had been reinforced only part height. There was considerable minor cracking that spalled small plaster fragments, cracked window corners (Figure 16 right), and hairline cracks in the adobe brickwork as visible in Figure 17.

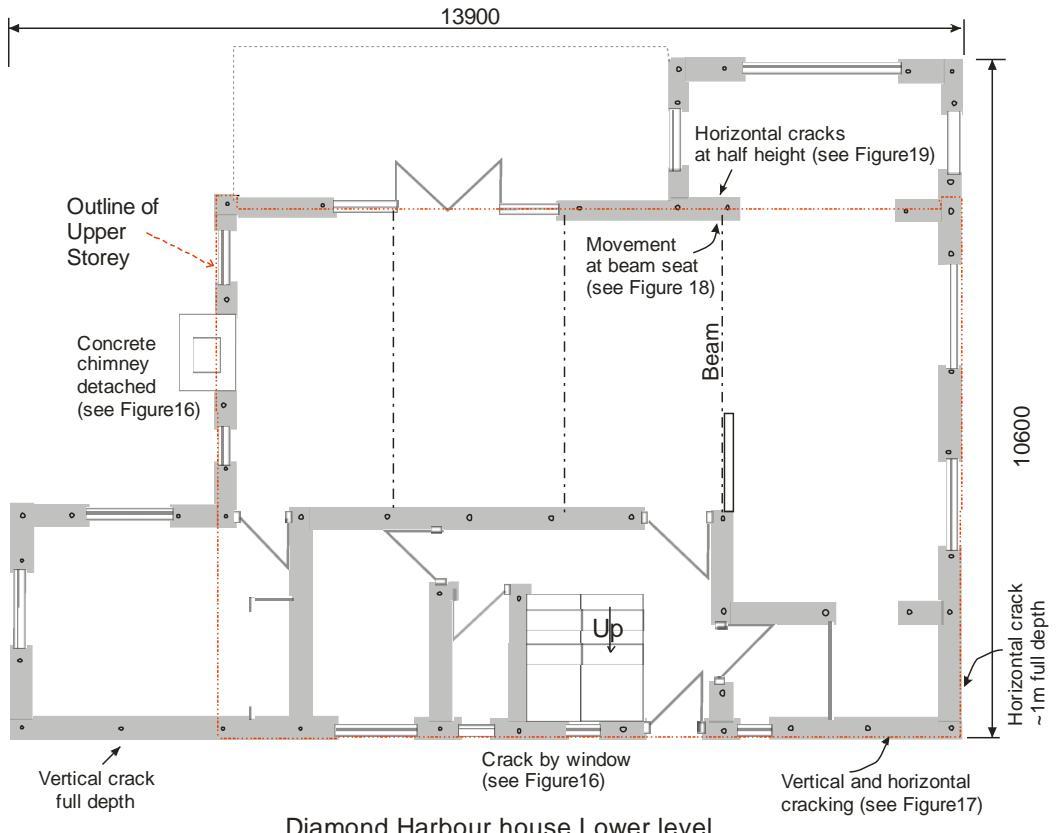
Figure 14: Diamond Harbour adobe house plan showing location of damage observed and vertical reinforcement.

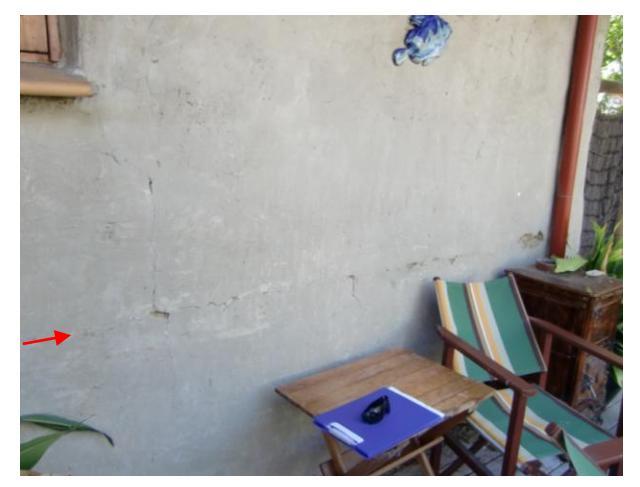
Figure 17: Diamond Harbour house showing cracks on south wall adjacent to entry. (G North)

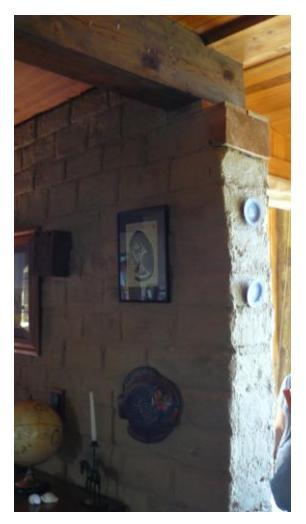
The main item of structural interest was the stub wall supporting a beam which fractured at about half height as shown in figures 18 and 19.

Figure 18: Diamond Harbour house showing beam landing on the stub wall.

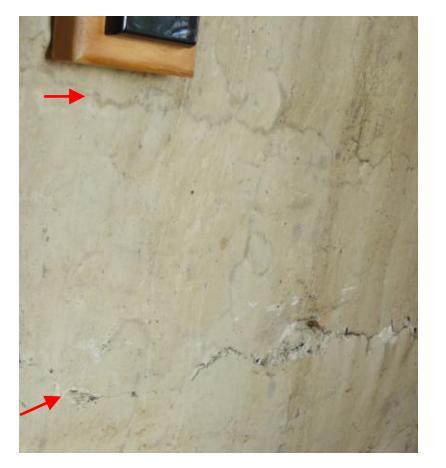
Figure 19: Diamond Harbour house showing the stub wall mid height horizontal cracks due to out-of-plane flexure.

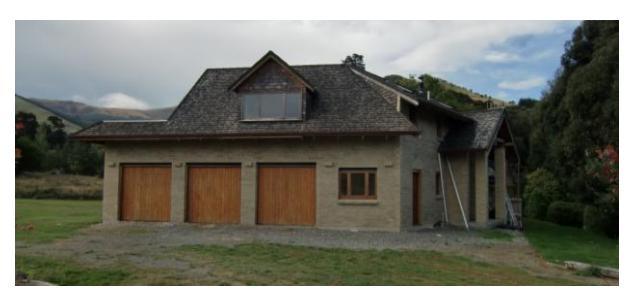
Figure 25: Little River pressed earth house 18 side view showing garages with insufficient adjacent bracing walls. (G North)

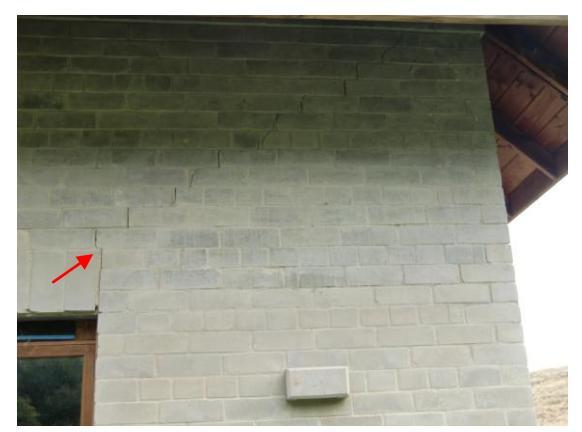
Figures 26 and 27 show the types of cracking adjacent to openings at the locations highlighted in Figure 23.

Figure 26: Little River pressed earth house 18 showing cracking of the pressed brick veneer.

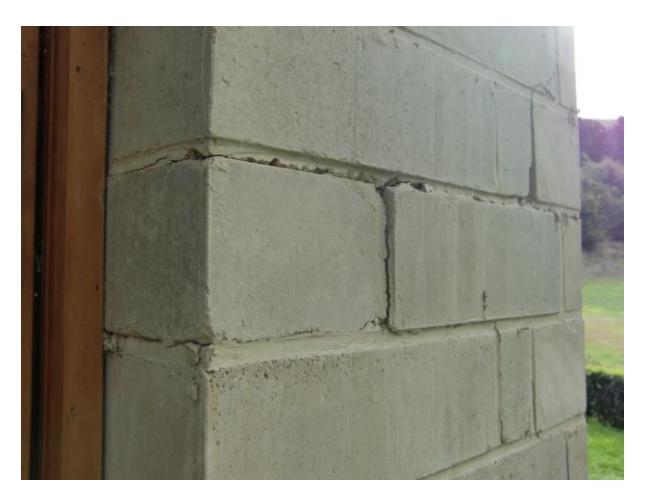
Figure 27: Little River pressed earth house 18 showing cracking of veneer.
