# Mechanical behaviour of earthen materials: A comparison between earth block masonry, rammed earth and cob

Article in *Construction and Building Materials* · June 2014

# Mechanical behaviour of earthen materials: a comparison between earth block masonry, rammed earth and cob

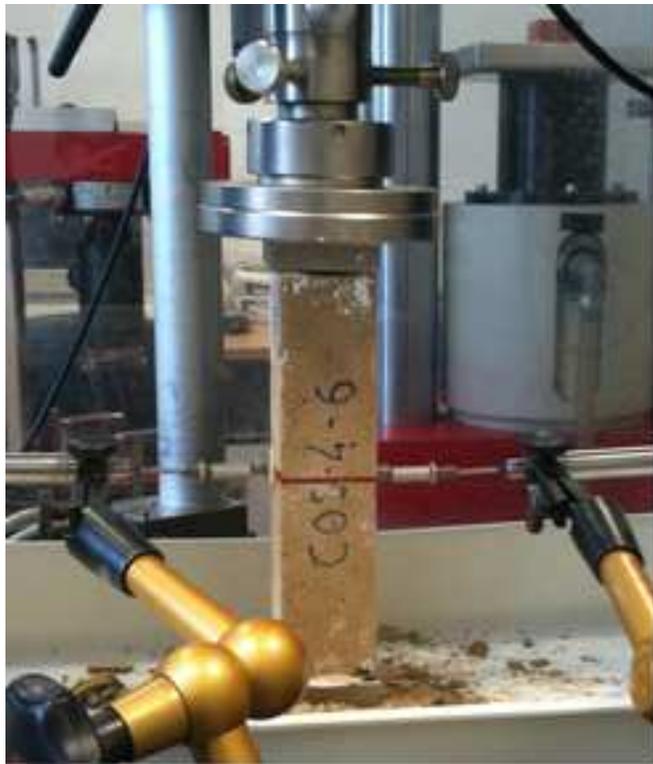
14  
15 **Fig. 5.** (a) Failure mode of a specimen at the mortar-block interface; (b) Correlation between shear strength and  
16 pre-compression load to determine initial shear strength.

The initial shear strength of the earth mortar and its bond behaviour to the earth block were found to be of particular interest. Therefore, shear tests according to EN 1052-3 [44], procedure A, were carried out on a 50 kN universal press with a pressure cell in horizontal position to adjust the pre-compression load perpendicular to the

bed joints of the specimens (Fig. 5). The specimens consisted of earth blocks, which were laid on each other with earth mortar joints. Shear strength values thus obtained are dependent on sliding at the mortar-block interface. Therefore, two joints are tested simultaneously. The joint width was adjusted to 20 mm, according to the joint width of the masonry wallette (see below). After preparation, the specimens were stored at 23 °C and 50 % RH for at least 14 days until testing.

The initial shear strength and the shear strength values at the respective pre-compression loads were very low compared to masonry with hydraulic mortar (Fig. 5). Failure did not occur at the joints but, instead, in almost all cases, at the mortar-block interface. That means that even though the mortar has a compressive strength equivalent to 2/3 of the earth block's compressive strength, contact between the two materials was a very weak point concerning shear behaviour. This, together with shear behaviour under diagonal compression for wallettes, is discussed below.

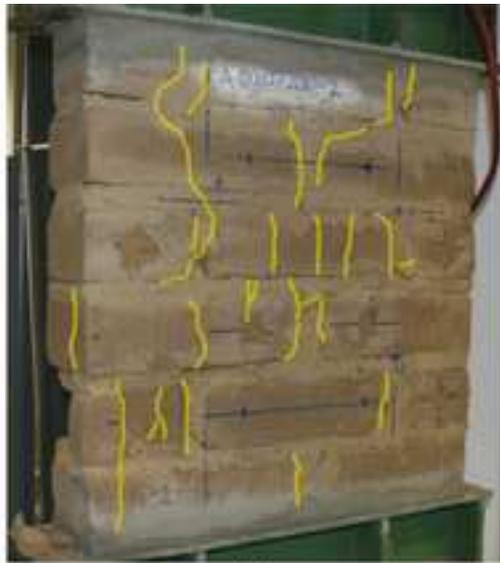
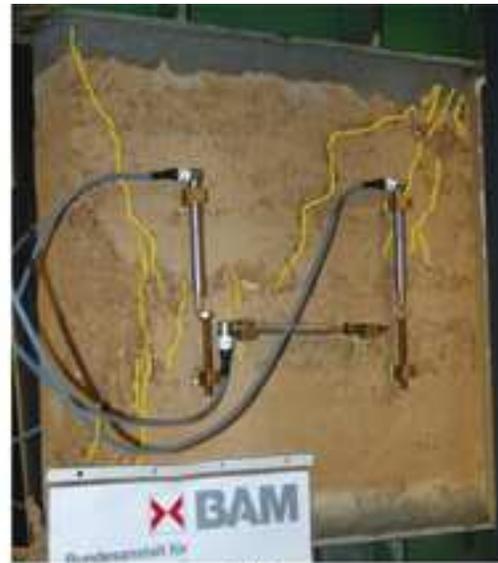
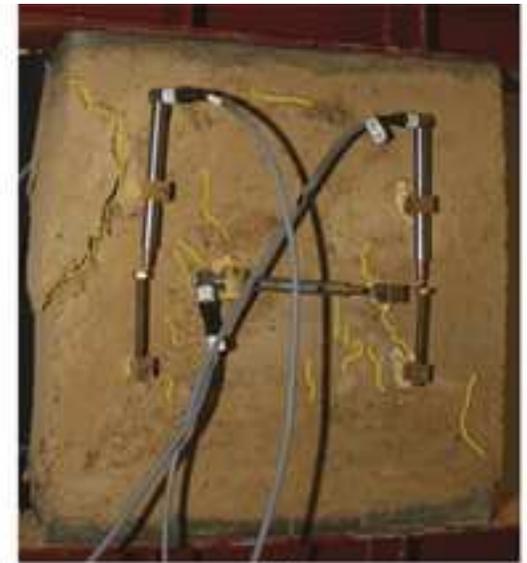
31  
32 **Fig. 10.** Earth block masonry (a), rammed earth (b) and cob (c) specimens under uniaxial compression. Crack  
33 patterns (cracks marked in yellow lines).

Test set-up and results are shown in Fig. 10. For earth block masonry wallettes, strength values ranged between 2.7 and 3.8 MPa. Ultimate vertical strain varied between 0.5 and 1.2 % and usually exhibited abrupt failure. An example of the failure patterns of the wallettes is depicted in Fig. 10. Failure was visible by vertical or diagonal cracks. On some specimens, a cone-shaped failure pattern was observed.

Rammed earth wallettes reached the highest compressive strength of all three types of earth constructions. The values ranged between 3.4 and 4.0 MPa. The deformations of the earth block masonry and rammed earth wallettes were similar. Failure was abrupt after maximum stress was reached. At failure the rammed earth specimens showed cone shaped cracking pattern, at least on one side, sometimes on both sides. Cob showed a completely different behaviour under compressive load than the other two construction types. Maximum strength ranged from 1.4 to 1.7 MPa. Deformations measured were high reaching up to 6 % vertical strain. Due to the content of straw the material showed a ductile behaviour under compressive load with no distinctive maximum. Crack patterns after the tests were almost random and only in one specimen a cone shaped failure was indicated.

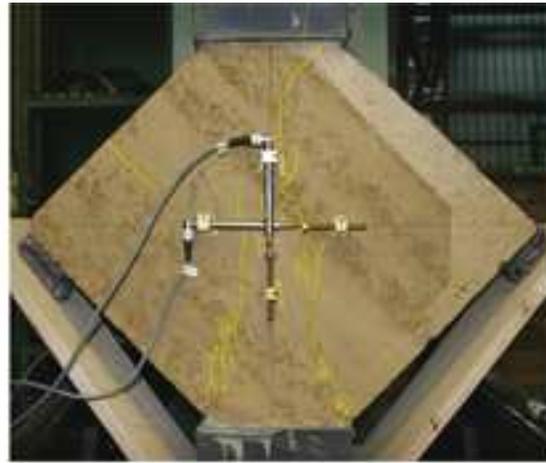
42  
43 **Fig. 14.** Earth block masonry (a), rammed earth (b) and cob (c) specimens under diagonal compression. Crack  
44 patterns (cracks marked in yellow lines).

Masonry wallettes with non-wetted blocks showed very low shear strength values, which were in the range of 0.08 to 0.11 MPa. Stress-strain curves usually showed one or several yield points where the blocks began to slide gradually until friction set in and increased stress again until final failure. Masonry wallettes with wetted blocks showed much higher shear strength values than with non-wetted blocks. For the three tests, strength values between 0.25 and 0.40 MPa were reached, which is two to three times higher than in the case of non-wetted blocks. The stress-strain curve for two of the three specimens showed a distinctive yield point, when elasticity of the specimens was exceeded and first cracks appeared. Subsequently, stress increased until the specimen failed. Ultimate strain values were approximately the same for both sets of wallettes. This type of stress-strain response can be linked to the actual failure mode of the specimen. The specimen yields the stress until the first vertical crack appears by exceeding the maximum elastic horizontal strain. The crack ran not only along joints but also through blocks. At the second yield point the specimen failed due to sliding of the blocks along the joints until complete collapse occurred (Fig. 14).
