**Cob: A Sustainable Building Material**

## **SENIOR DESIGN PROJECT REPORT**

Santa Clara University, Spring 2018

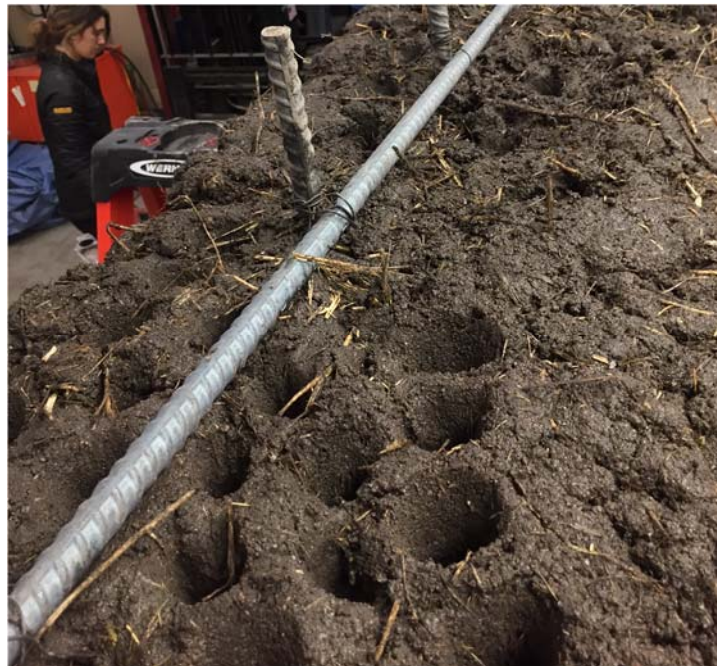
section “3.2.0 Mix Design”. Once the mixture was complete, the cob was then manually formed onto the walls and integrated into the previous lift with a technique called “thumbing.” Thumbing involves placing a lump of cob onto the structure and then using a stick or thumb like object to push the new cob into the previous layer. This technique is done every few inches to insure the straw was thoroughly integrated into the previous layer. CRI Director, John Fordice, provided a demonstration for proper thumbing techniques. A visual of a layer of cob that has been thumbed is shown below in *Figure 1*.

*Figure 1: Example of Thumbbed Cob.*

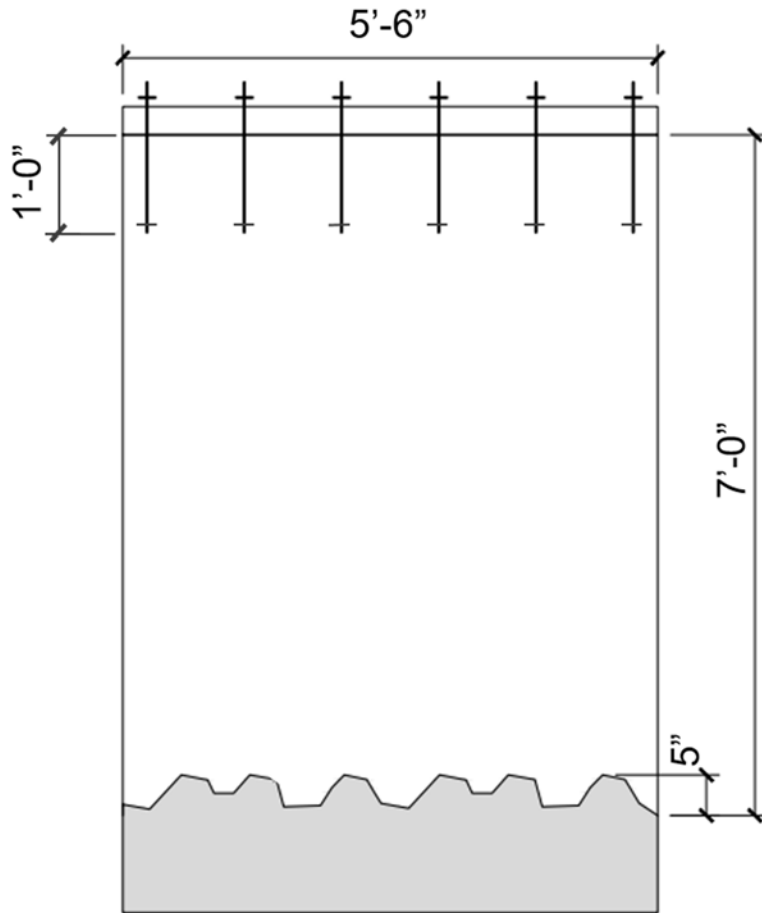
The first wall system was a common practice wall shown in *Figure 2*. Wall 1 (Common Practice) has no steel reinforcing structure, apart from the six (6) pieces of #5 threaded rod spaced 12 inches on center at the top of wall. The threaded rods were added to transfer load from the top plate timber members to the cob wall and were embedded 12 inches into the wall with 2.5x2.5 bearing plates at the bottom. At six feet of height, a scaffolding system was constructed to hold the rods in place as cob was packed around them. To avoid shearing through the cob, the threaded rod had a minimum edge spacing of 3 inches. A foundation of rocks protruding five to six inches out of the concrete base shown in *Figure 3* was designed to mimic common cob practices. The rocks were placed while the concrete was setting at the perimeter of where the cob was to be placed as well as laterally throughout the wall at 12 inch intervals. The purpose of this wall was to give insight into how existing cob structures perform when laterally loaded. Wall 1 had a height of seven feet (7'), a length of five feet six inches (5'6"), and a depth of 16 inches (16"). The wall had a 1.25:1 aspect ratio to encourage a shear failure in the wall.

*Figure 2: Wall 1 Reinforcement System (Common Practice).  
Drawing Courtesy of Verdant Structural Engineers*

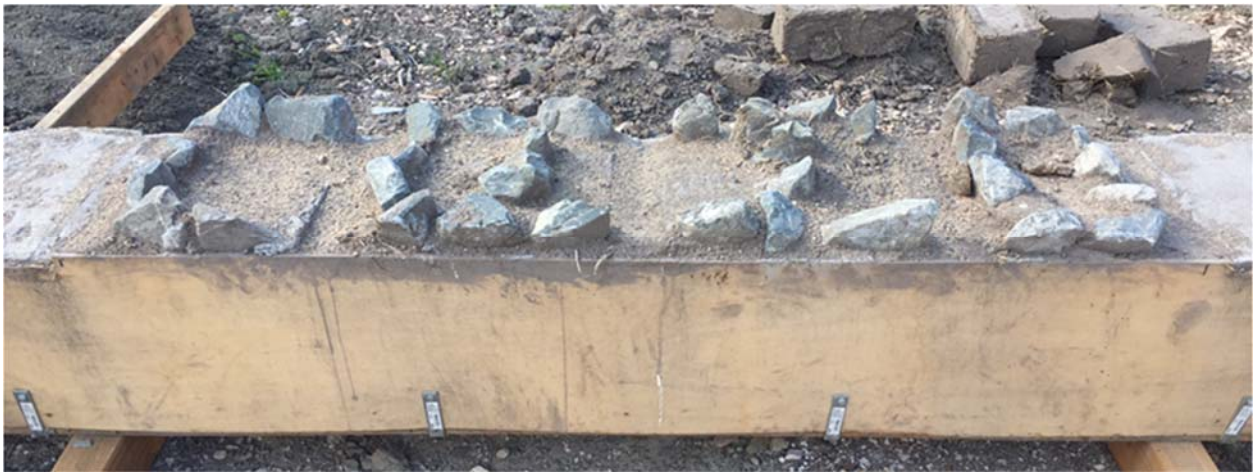
*Figure 3: Wall 1 Base Design (Common Practice).*

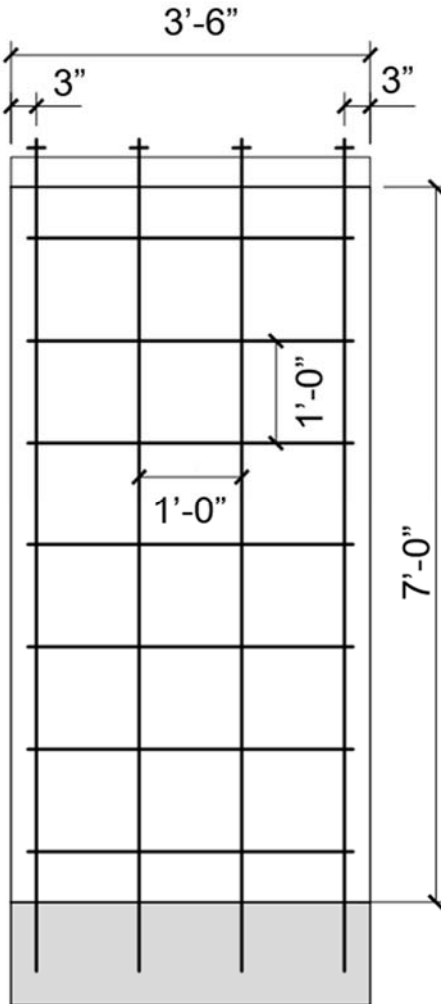
The reinforcement method for Wall 2 was a rebar matrix, with horizontal #5 rebar installed 12 inches (12") on center and four vertical pieces running the full seven foot (7') height. The configuration can be seen in *Figure 4*. The #5 rebar was embedded into the concrete base and secured with scaffolding until the wall could support the rebar cage. Similar to Wall 1, there was a minimum three inch (3") coverage between the rebar and outside of the wall. Horizontal pieces of rebar were placed on top of the wet cob and tied to the vertical rebar with tie wire as construction progressed. The top two feet (2') of rebar were replaced with couplers and threaded rod protruded six inches (6") out of the top of the wall, allowing for tie in to the top plate. The purpose of the rebar in this wall was to replicate the kind of reinforcement found in a typical concrete wall. This wall was constructed and tested to determine how the cob interacts with rebar and determine its viability to add strength and ductility to a cob structure. Wall 2 had a reinforcement configuration and aspect ratio different from the previous wall. At a length of three feet and six inches (3'-6"), Wall 2 had an aspect ratio of 2:1 to induce a flexural failure.

Figure 4: Wall 2 Reinforcement System (Heavy Reinforcement).  
 Drawing Courtesy of Verdant Structural Engineers

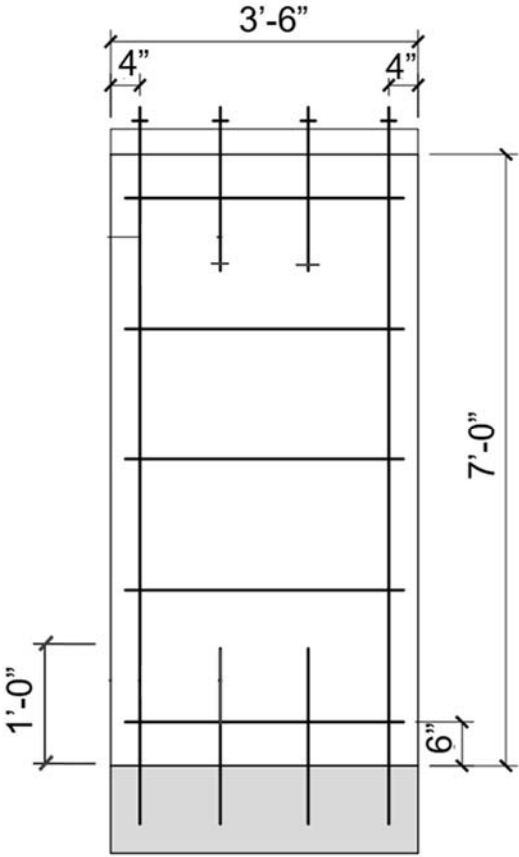
The reinforcement method for Wall 3 utilized rebar and welded wire mesh, with 14 gauge welded wire mesh installed horizontally every 18" on center and two (2) vertical pieces of #5 rebar running the full seven foot (7') height. In addition to the full length rebar, two pieces of #5 threaded rod were placed in between at 12 inches (12") on center on both the top and bottom of the wall, penetrating the cob 12 inches (12"). Bearing plates, which were 2.5" x 2.5", were placed at the bottom of the all thread rods at the top of the wall to help transfer the load from the MDOF test frame into the wall. The configuration can be seen in *Figure 5*. The #5 rebar was embedded into the concrete base and secured with scaffolding until the wall could support the rebar cage. Similar to Wall 1, there was a minimum three inch (3") coverage between the rebar and outside of the wall. Horizontal pieces of welded wire mesh were placed on top of the wet

cob as construction progressed. The top two feet (2') of rebar within the wall was replaced with couplers and threaded rod protruding six inches (6") out of the wall to allow for tie in to the top plate. The purpose of the rebar and welded wire mesh was to reinforce the wall with materials that would be easier to use in the field. Welded wire mesh is a lighter material that is easier to transport and cut compared to rebar. This wall was constructed and tested to determine how the cob would interact with the welded wire mesh and rebar to see if these materials would help increase the ductility and strength of the wall. Wall 3 had a different reinforcement configuration, but the aspect ratio was the same as the previous wall. At a length of three feet and six inches (3'-6"), Wall 3 had an aspect ratio of 2:1 to induce a flexural failure.

*Figure 5: Wall 3 Reinforcement System (Medium Reinforcement).  
Drawing Courtesy of Verdant Structural Engineers*

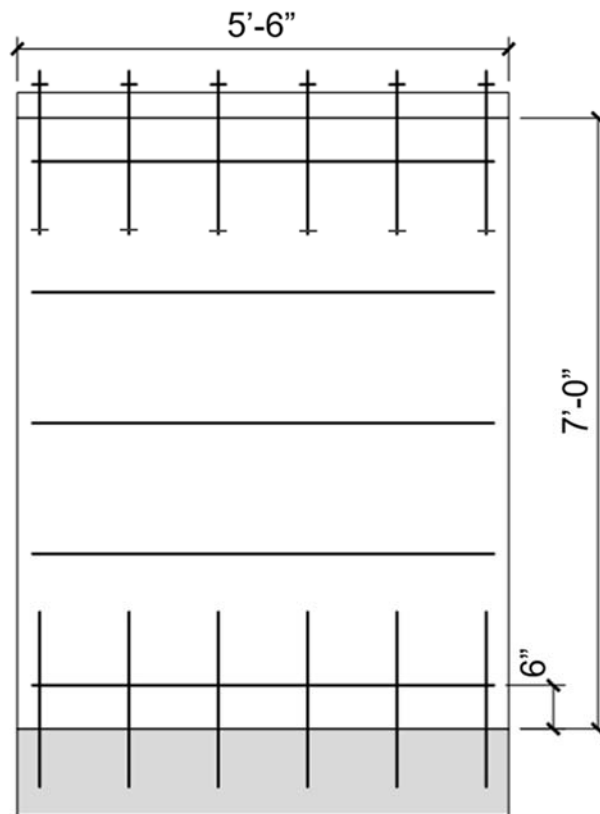
The reinforcement methods used for Wall 4 combined all thread rods and welded wire mesh, similar to Wall 3. Vertical #5 threaded rods penetrated 12 inches (12") into the cob at the top and bottom of the wall. Bearing plates, which were 2.5" x 2.5", were added to the bottom of the threaded rods at the top of the wall to help transfer the load from the MDOF test frame into the cob. The threaded rods were placed 12 inches (12") on center along the middle of the base and top of the wall. Welded wire mesh was used for the horizontal reinforcement of Wall 4. The first layer of welded wire mesh was placed 6 inches above the top of the base and the following layers of the mesh were placed 18 inches (18") on center for the remainder of the wall. The reinforcement of Wall 4 can be seen in *Figure 6*. Wall 4 was constructed and tested to determine how the cob would interact with the welded wire mesh if there was no vertical reinforcement that ran the entire height of the wall. Wall 4 had a height of seven feet (7'), a length of five feet six inches (5'6"), and a depth of 16 inches (16"). The wall had a 1.25:1 aspect ratio to encourage a shear failure.

*Figure 6: Wall 4 Reinforcement System (Light Reinforcement).*

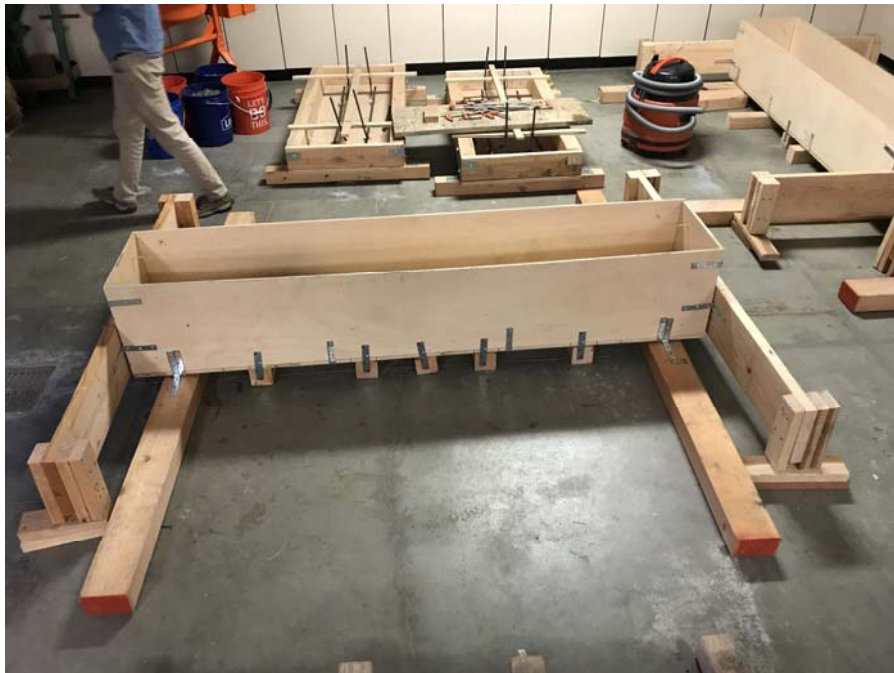
To finalize the bases, an outrigger system was designed. The outriggers were included to add stability to the walls both during construction and for the three months of drying. The system included two 4x6 timber beams, which were placed underneath the edge of each base and extended out three feet on each side as shown in *Figure 7*.

*Figure 7: Completed Base for a 1.25:1 Aspect Ratio Cob Wall.*

In addition, 4x4 pieces of lumber were placed beneath the wall at six inch (6") intervals. These 4x4 pieces did not extend beyond the width of the base, supporting the base and preventing deflection between the 4x6 beams. This design allowed enough space for forks to get underneath the wall. The limited space in the MDOF test frame required the outriggers to be removable and the base to sit flush to the ground.

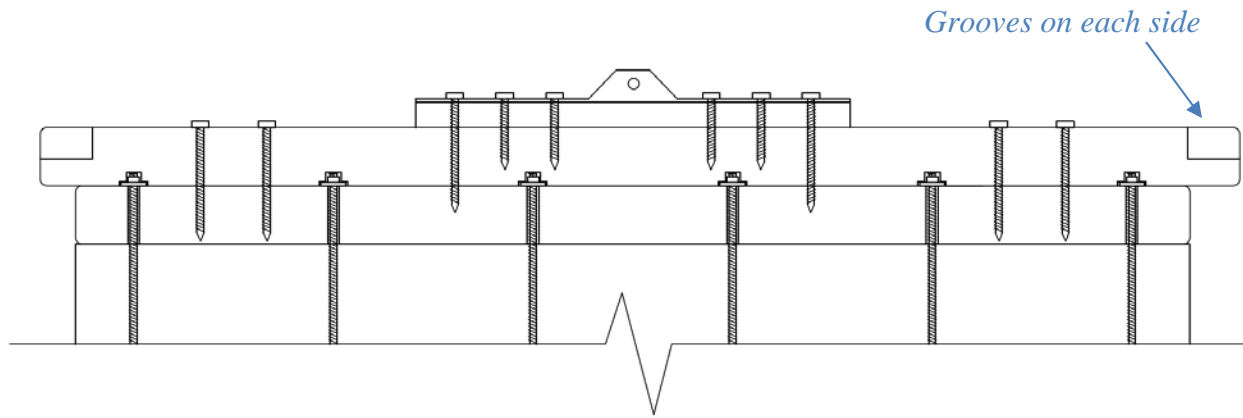
the top plate for both ease of construction and adequate strength. An elevation view of the top plate can be seen in *Figure 8*.

*Figure 8: Top Plate Design Configuration.*

The top plate, as with the base of walls, was designed for 3,440 pounds per linear foot of lateral load, to ensure that failure occurred in the cob wall system. Immediately after the final lift of cob was applied, a 4x8 flat piece of Douglas fir north, running the length of the wall, was embedded into the wet cob. Holes were drilled so that the six pieces of threaded rod in the cob could penetrate through the embedded 4x8. Threaded rods were then secured with washers and bolts. After the cob dried, an additional 4x8 flat piece was placed above the original for constructability of the pin connection to the MDOF test frame. The two pieces of timber were then secured together using eight three quarter inch ( $\frac{3}{4}$ " ) lag screws to act as one cohesive top plate. In addition, six one inch (1") diameter lag screws were used to fasten the steel plate pin connection to the upper 4x8 member. Shear force in the bottom 4x8 transferred by the threaded rod, governed the design of the top plate. Shear force through the member was found using *Equation 2*

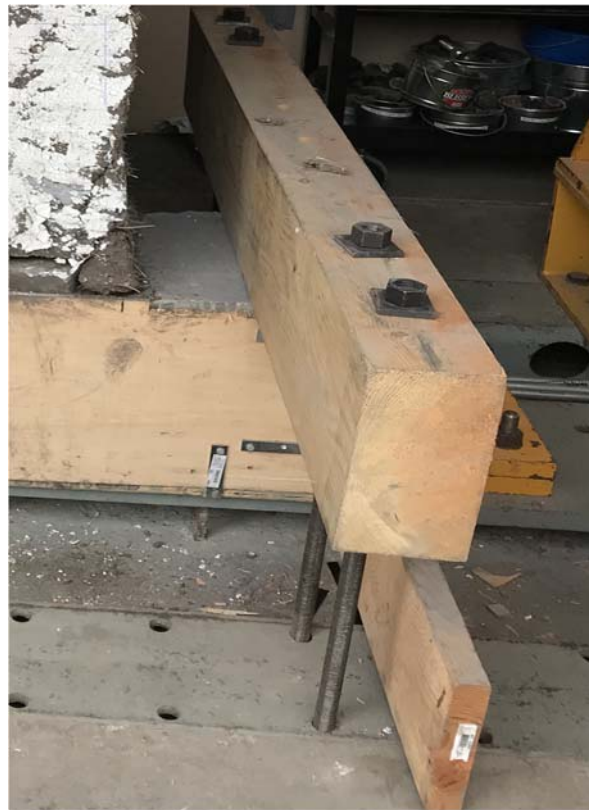
Each wall needed to be restrained in the MDOF testing frame to prevent overturning and sliding. To resist overturning, a select structural Douglas fir 6x10 beam was placed horizontally across the concrete base and tied into the strong floor with two one inch (1") diameter threaded rods at each end, as shown in *Figure 9*. Calculations were completed to verify that the timber and rods were sufficient to resist the estimated maximum lateral force of 18,900 pounds.

*Figure 9: Wall Testing Restraint System.*

Based off of the estimated design load of 18,900 pounds, the maximum moment was 16,000 pound feet. The maximum allowable moment of the timber was 18,000 pound feet. The estimated forces required each rod to be able to resist a maximum uplift force of 4,560 pounds. The limiting factor of this system is the wooden beams. To verify that the bearing plate would not cause the wooden beam to fail, the maximum shear calculation was completed for the metal plates. Using the NDS (NDS 2012), it was determined that it would require 68,750 pounds for the metal plate to shear through the 11” height of the timber beam. These calculations showed that the restraint system would be able to resist the forces produced by the MDOF testing frame, during the cyclical loading of the four walls.

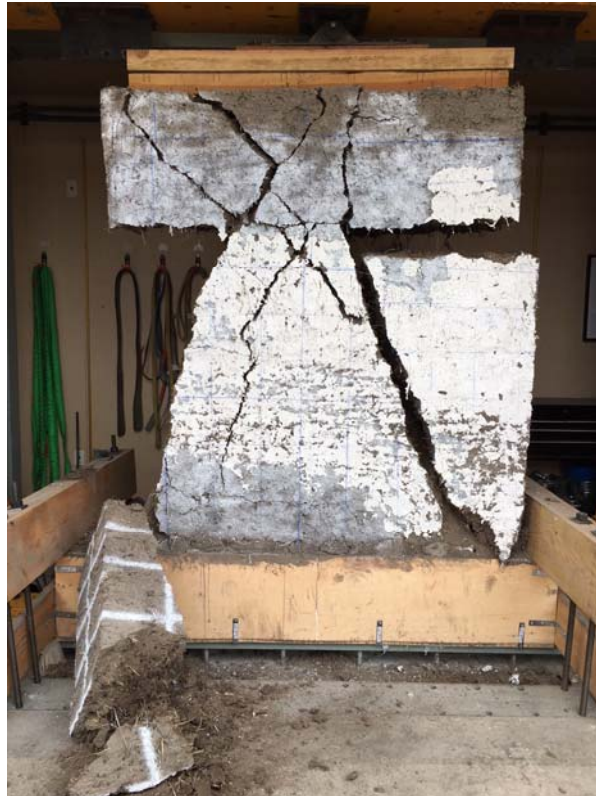
The first wall tested was the common practice wall (1.25:1 ratio). In the cyclic loading machine, the wall took a lateral force of 1183 pounds per foot or 6509 pounds total. The wall failed prior to reaching the maximum displacement in the machine (8.4 inches). Wall 1 took more lateral force than its self-weight of 5,745 pounds. This wall failed in shear, and the diagonal cracks can be seen below in *Figure 10*.

*Figure 10: Wall 1 (Common Practice) After Testing.*

The ultimate failures in the wall developed along a lift, indicating these may be a weak point in the material. Before failure, the wall had some minor uplift off of the stone connections in the base, indicating that load was being transferred through all seven feet of the wall.

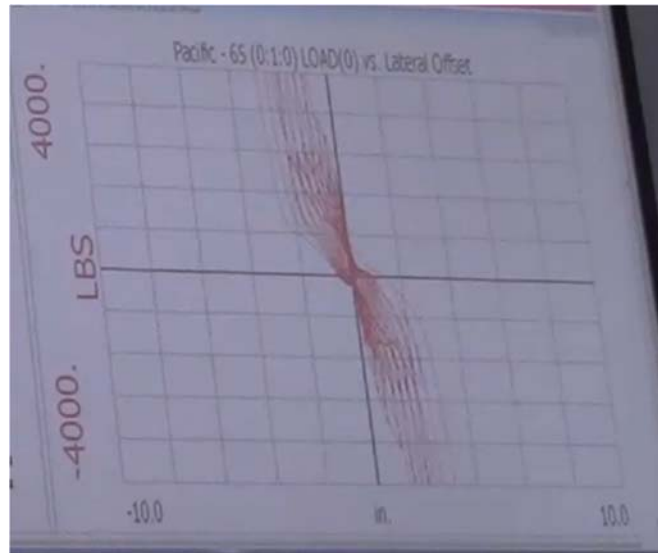
Unfortunately during this test, the data tracking the stress and displacement of the wall was not recorded. Some data involving peak loads was able to be extracted from the video data thanks to Santa Clara University student Jose Espinoza. The hysteresis loops show a maximum displacement of 2.5 inches, which can be seen in *Figure 11*.

*Figure 11: Wall 1 (Common Practice) Hysteresis Diagram.*

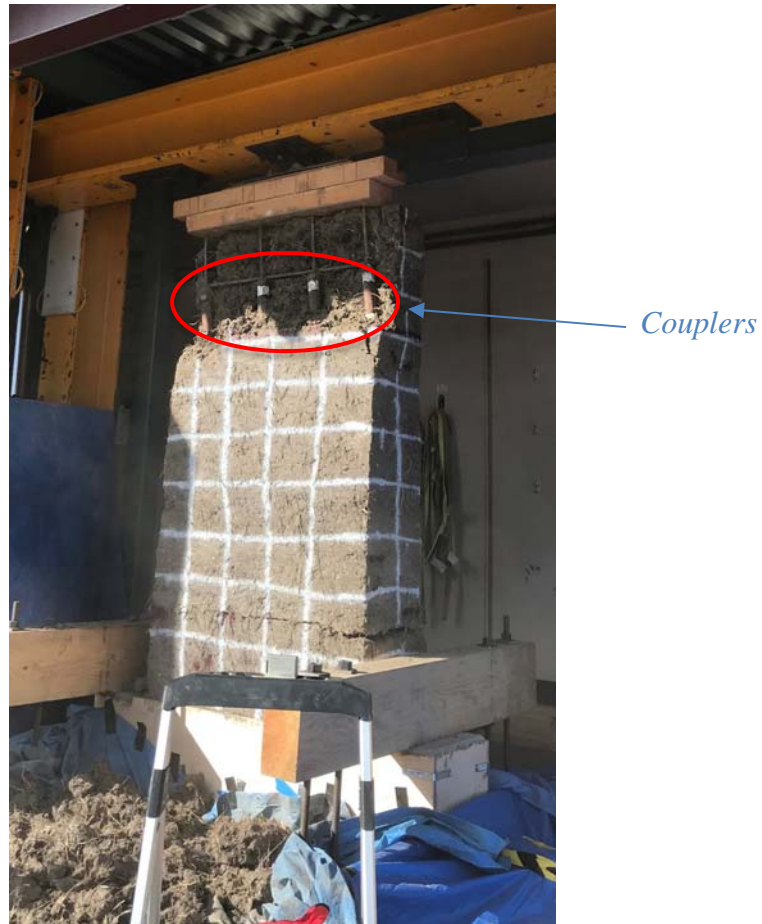
The heavily reinforced (2:1 aspect ratio) received a maximum lateral force of 887 pounds per foot or 3104 pounds total. This heavily reinforced wall utilized couplers in the construction of the rebar cage. A horizontal crack was observed prior to testing Wall 2. The couplers added to this wall were likely the source of the crack and may have decreased the maximum lateral load the wall could resist. Failure occurred at the base of the couplers which can be seen in *Figure 12*.

*Figure 12: Wall 2 (Heavily Reinforcement) After Testing.*

In addition, the rebar did not integrate well with cob. As the test continued, the rebar created voids in the cob, indicating the steel cage and cob were moving independently. Unlike concrete, the cob did not bond with the rebar, suggesting a full rebar cage is not the ideal reinforcement mechanism for cob. The hysteresis loops in *Figure 13*, show Wall 2 had five inches (5”) of lateral offset. The hysteresis loops for Wall 2 also show a significant decrease in load as the lateral displacement increases.

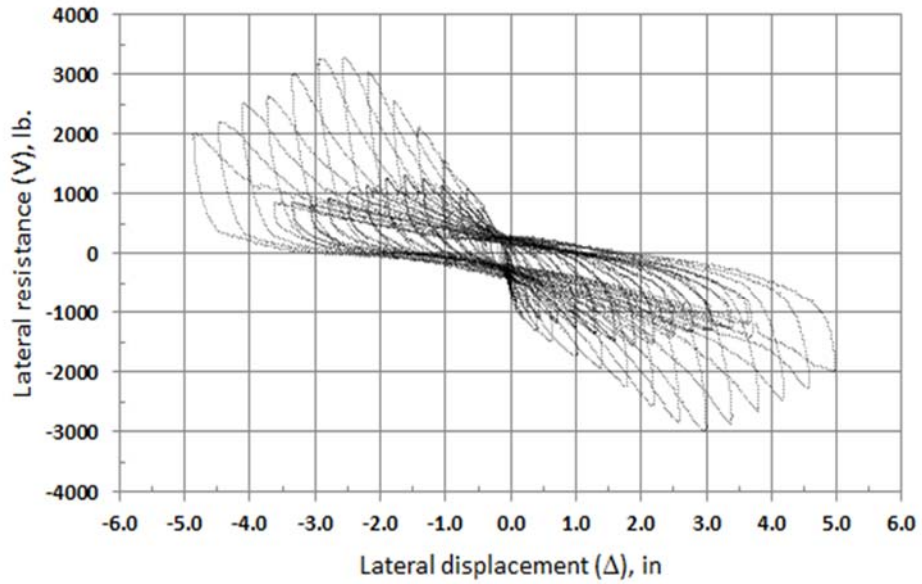
Figure 13: Wall 2 (Heavily Reinforcement) Hysteresis Diagram.

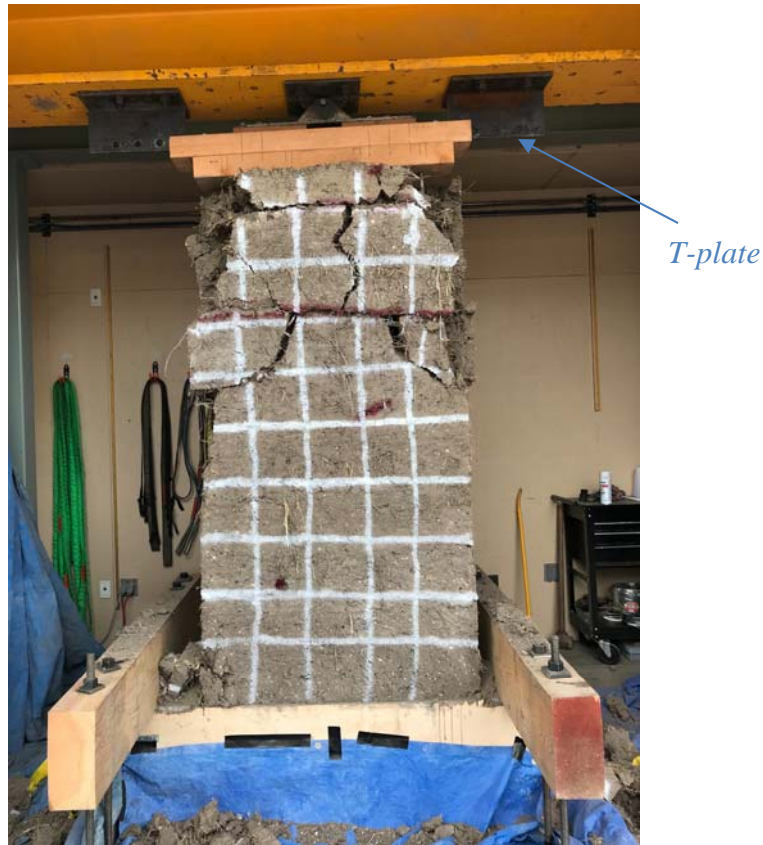
The medium reinforced wall (2:1 aspect ratio) experienced a peak load of 1342 pounds per foot and a total force of 4693 pounds. Wall 3 failed in the plane where the couplers were installed, as can be observed in *Figure 14*.

*Figure 14: Wall 3 (Medium Reinforcement) After Testing.*

The welded wire mesh offered many different points of contact for the surrounding cob, helping the two move as one unit. The rebar, which ran the total height, appeared to distribute forces horizontally to each piece of mesh. The hysteresis loops in *Figure 15* show eight inches (8") of displacement, completing all cycles on the MDOF test frame without collapsing.

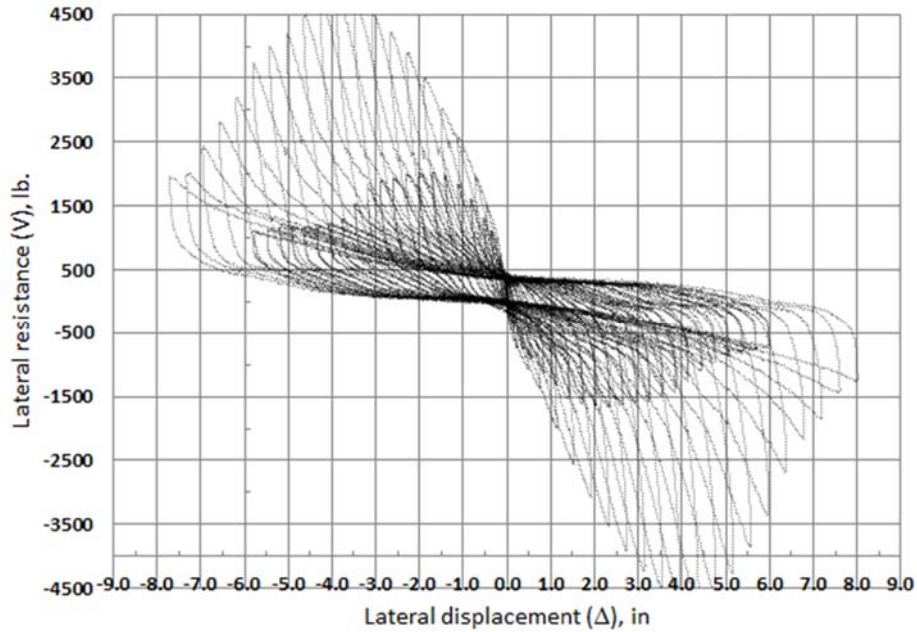
Figure 15: Wall 3 (Medium Reinforcement) Hysteresis Diagram.

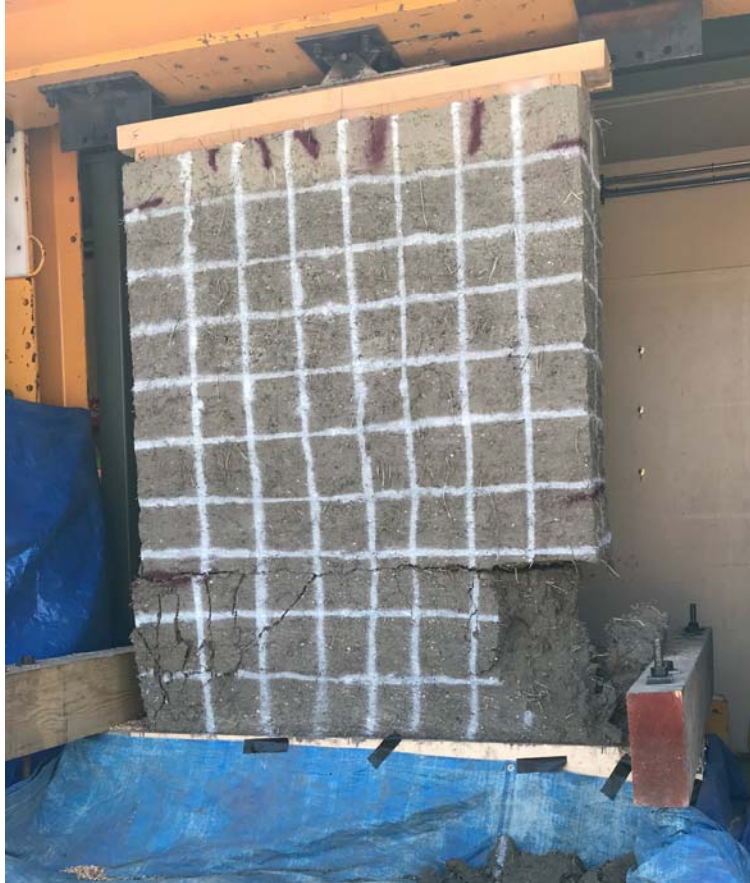
The lightly reinforced wall (1.25:1 aspect ratio) reached a maximum load of 6971 pounds of lateral force before failure, or 1267 pounds per lineal foot of wall. During the test, the metal plates attached to the testing frame began to bear on the wood top plate. The metal plates can be seen in *Figure 16*. As a result of the bearing, the wall was no longer being loaded solely through the pin. This may have created a higher peak, since the cob wall was not taking all of the load through the pin connection. Ultimately, it is nearly impossible to determine how the cob would act if the test frame did not come in contact with the wood member, so the values received must be analyzed accordingly.

*Figure 16: Wall 4 (Light Reinforcement) After Testing.*

The failure in Wall 4 occurred along a horizontal plane near the bottom of the wall roughly one hour into the test. The location of the failure was along the same plane as a lift, where construction was completed for the day. Shortly after cracks began to form, a large crack spread through the entire length of the wall 2 feet (2') about the base. The crack divided Wall 4 into two halves, only transferring load to the top of the wall. The base and bottom two feet (2') of cob only received a portion of the load. The portion of the wall above the crack was moving independently of the bottom for the remainder of the test. As a result, the hysteresis curve shows a drop of in load as the displacements grows. Had the test been concluded immediately after the failure of the wall, the maximum displacement of the system would be substantially less. As shown in the hysteresis loops in *Figure 17*, Wall 4 had a maximum lateral offset of 4.5 inches.

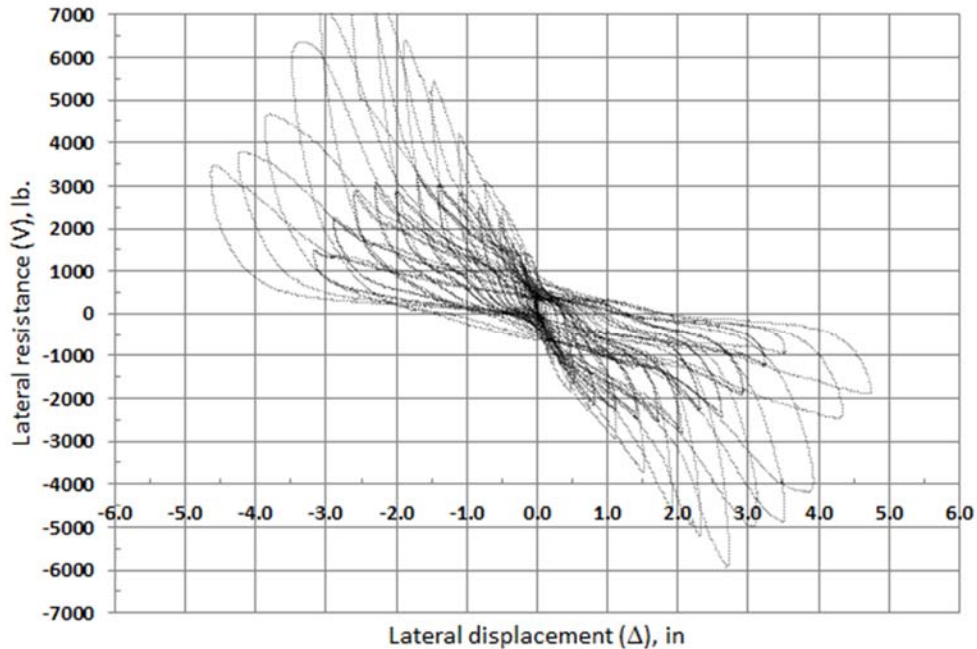
Figure 17: Wall 4 (Light Reinforcement) Hysteresis Diagram.

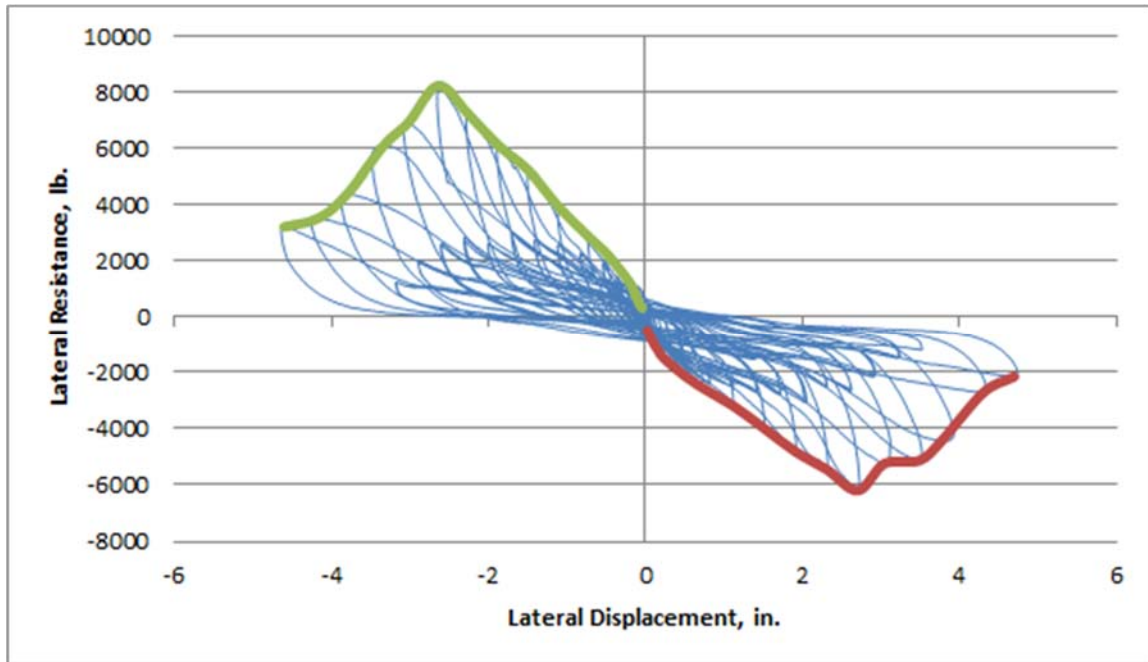
Using the hysteresis graphs found from the testing, approximations of the seismic response modification factors could be found. Before analyzing the data, bare frame corrections had to be accounted for to remove error in the data, created by friction in the testing frame. After completing these adjustments, envelope curves for each wall's graph could be determined. The maximum peak values and the envelope curves for Wall 4 can be seen below in *Figure 18*.

*Figure 18: Wall 4 (Light Reinforced) Maximum Peak Values.*

By taking the absolute value of each of the data points graphed, two stress strain curves for the wall were created, shown in red and green on *Figure 18*, which were averaged to find a final load vs. displacement plot for each wall. Each wall's stress strain curve was then plotted together as shown on *Figure 19*.

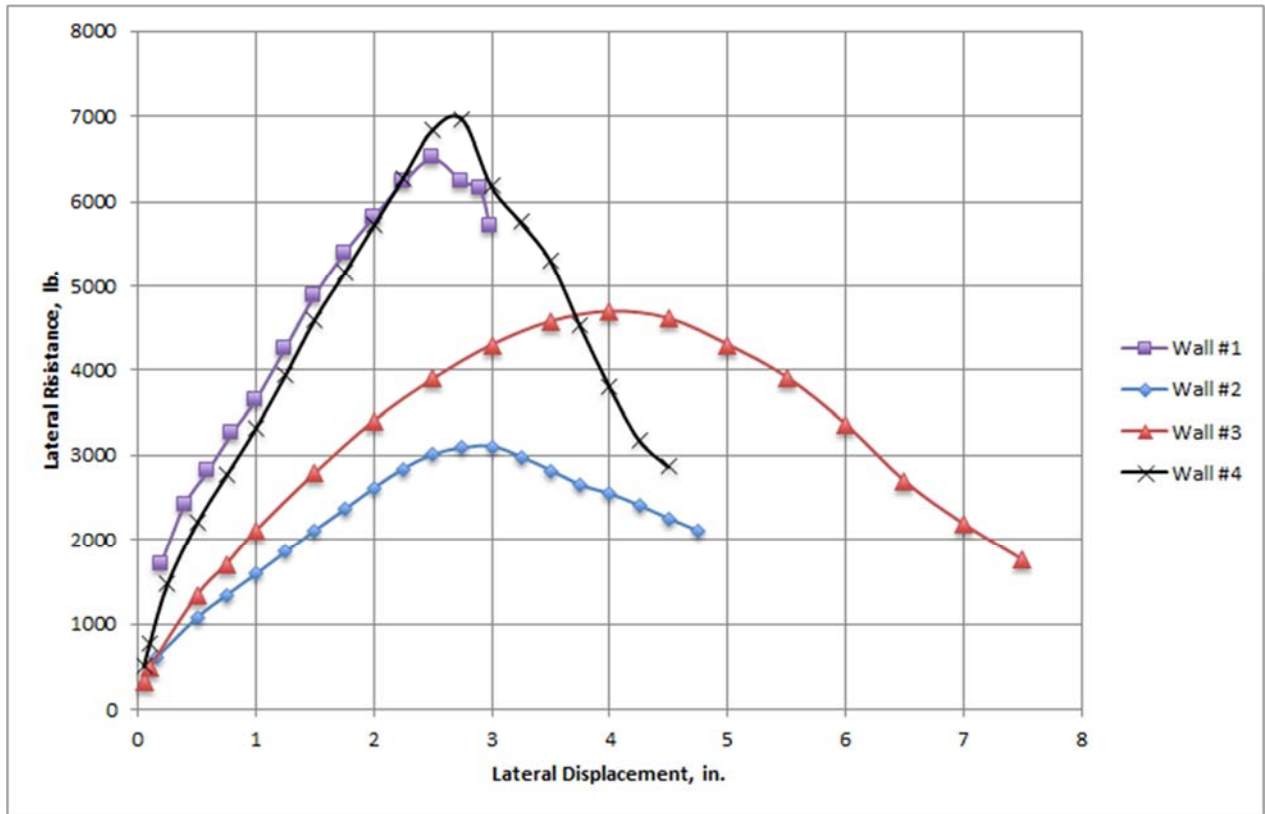
Figure 19: Stress Strain Curves for All Walls.

It is important to note that the data for Wall 1 was recovered using the video data and may contain more error than the others.

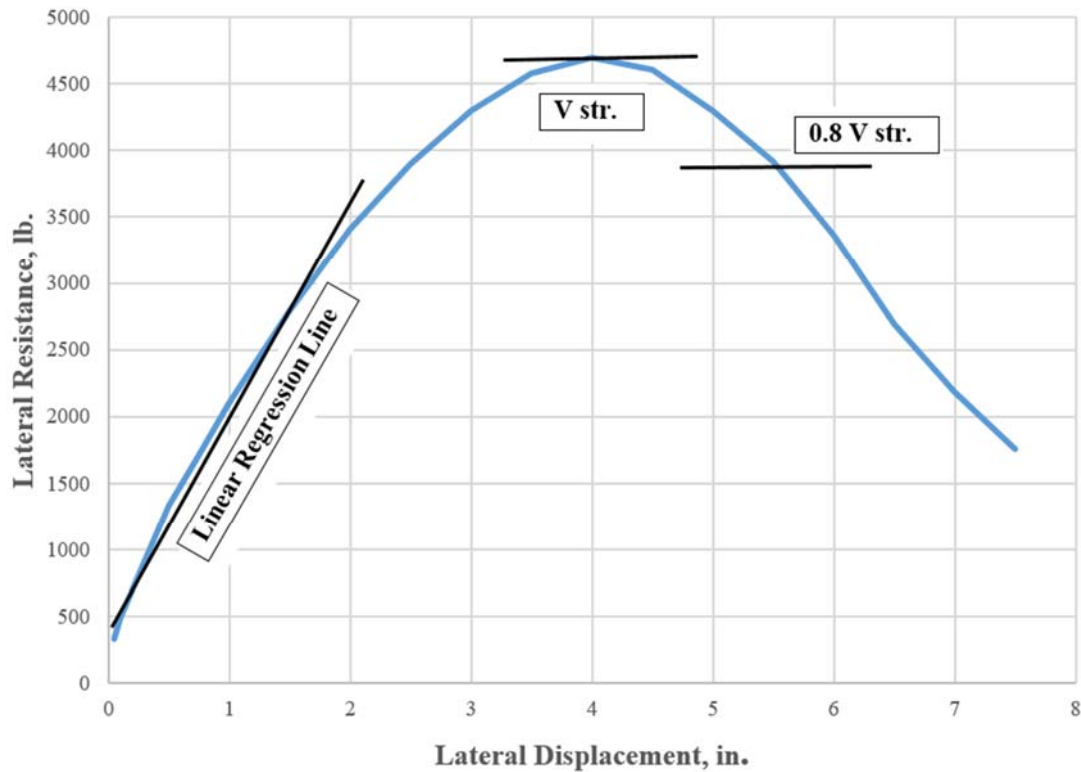
where  $V_{st}$  is the force at the peak load and  $\Delta_{st}$  is the maximum displacement ( $V_{st}$  values can be seen in Figure 20).  $V_y$  and  $\Delta_y$  are the force and displacement at the yield point, respectively. This method was used for each wall. The main difficulty in calculating these values came from determining where the yield point is on the graphs. The yield point exists where the graph becomes non-linear. These points were found using both visual inspection, and by using linear

regressions lines to determine  $R^2$  values for each wall's graph. Each line was considered linear until the  $R^2$  value dropped below 0.98. Any portions beyond the 0.98 value were considered to no longer be yielding. These values were averaged with a visual inspection of where the non-linear portion begins, to find the final values.

Figure 20: Wall 3 Linear Regression Analysis.

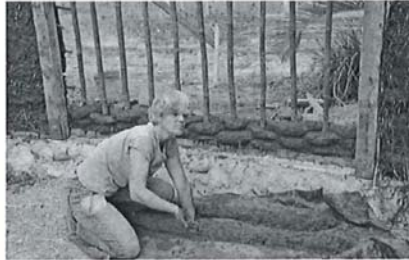
Fig 11. "snake-like" cobbing method around wattle frame

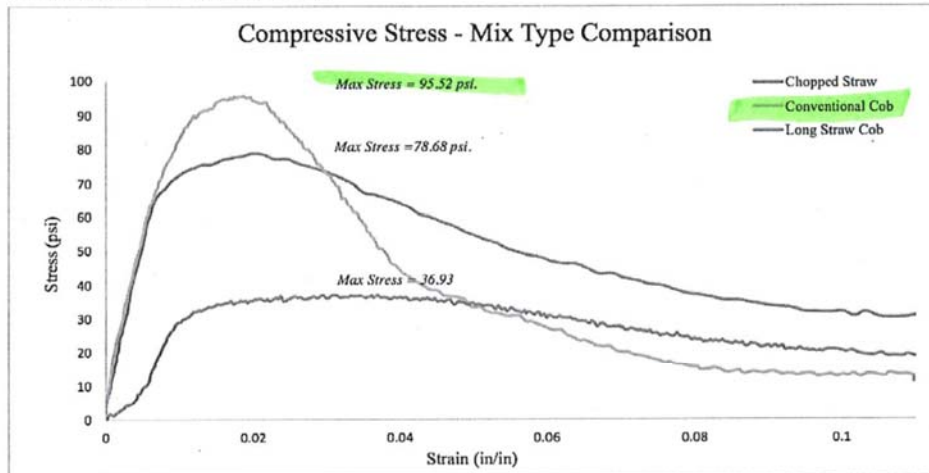
Fig 13 - Compressive Stress by Mix Type
