OBSERVATIONS OF THE PERFORMANCE OF EARTH BUILDINGS FOLLOWING THE FEBRUARY 2011 CHRISTCHURCH EARTHQUAKE

Hugh Morris¹ and Richard Walker²

SUMMARY

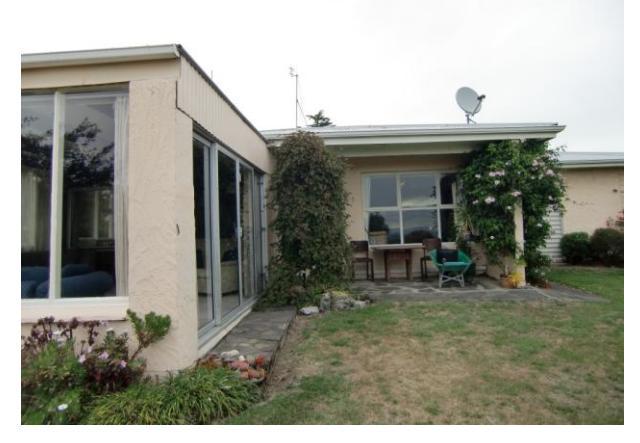
Unreinforced rammed earth building – Kennedys Bush Road House 23

A number of cement stabilized rammed earth houses were constructed in the late 1950s based on the research work of P.J.Alley at Canterbury University. (Alley, 1952) These houses were high quality unreinforced rammed earth and had a continuous reinforced concrete bond beam. Five of these houses remain in Kennedy's Bush Road and even with thin walls only suffered minor damage.

Figure 8: Unreinforced Rammed Earth Kennedy's Bush Road (Building 23) showing overall layout. New conventional addition to left front.

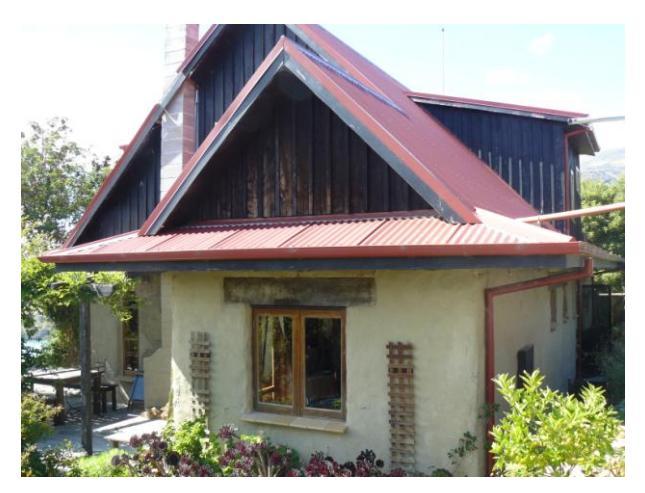
Reinforced adobe building - Diamond Harbour House 15

This reinforced adobe house used detailing and reinforcement that is similar to the New Zealand Standards (see Figure 15).

Figure 15: Diamond Harbour reinforced adobe house overall view.

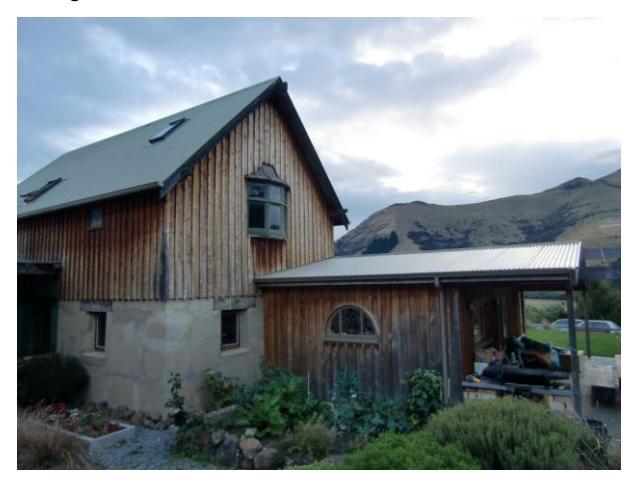
Rammed earth building - Little River House 19

At Little River, House 19 had 2.4 m high and 400 mm thick rammed external earth walls and 300 mm internal walls (Figure 20) that formed part of the lower storey. A 400 mm architectural feature wall stands alone as shown in figures 21 and 22. The walls had a strong timber well fastened bond beam. The house was greater than 22 km from the February epicentre with a reported intensity of MM V and although the walls supported a light timber frame upper level the only damage was hairline cracks that extended less than 500 mm.

Figure 20: Little River rammed earth house 19 overview showing exterior rammed walls.

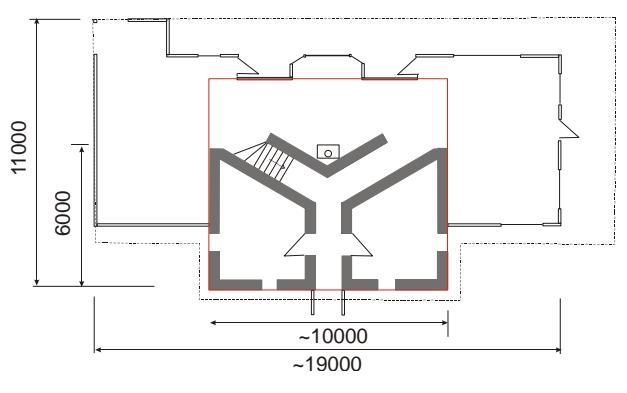
Figure 21: Little River rammed earth House 19 ground floor plan showing rammed walls and outline of upper storey.

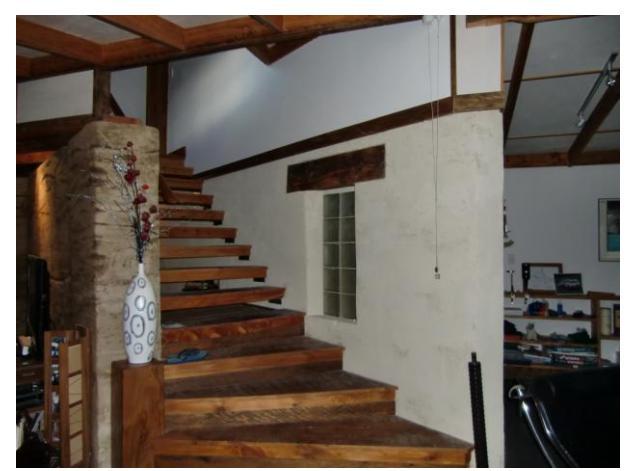
Figure 22: Little River rammed earth House 19 internal feature wall and stairway. (Photo G North)

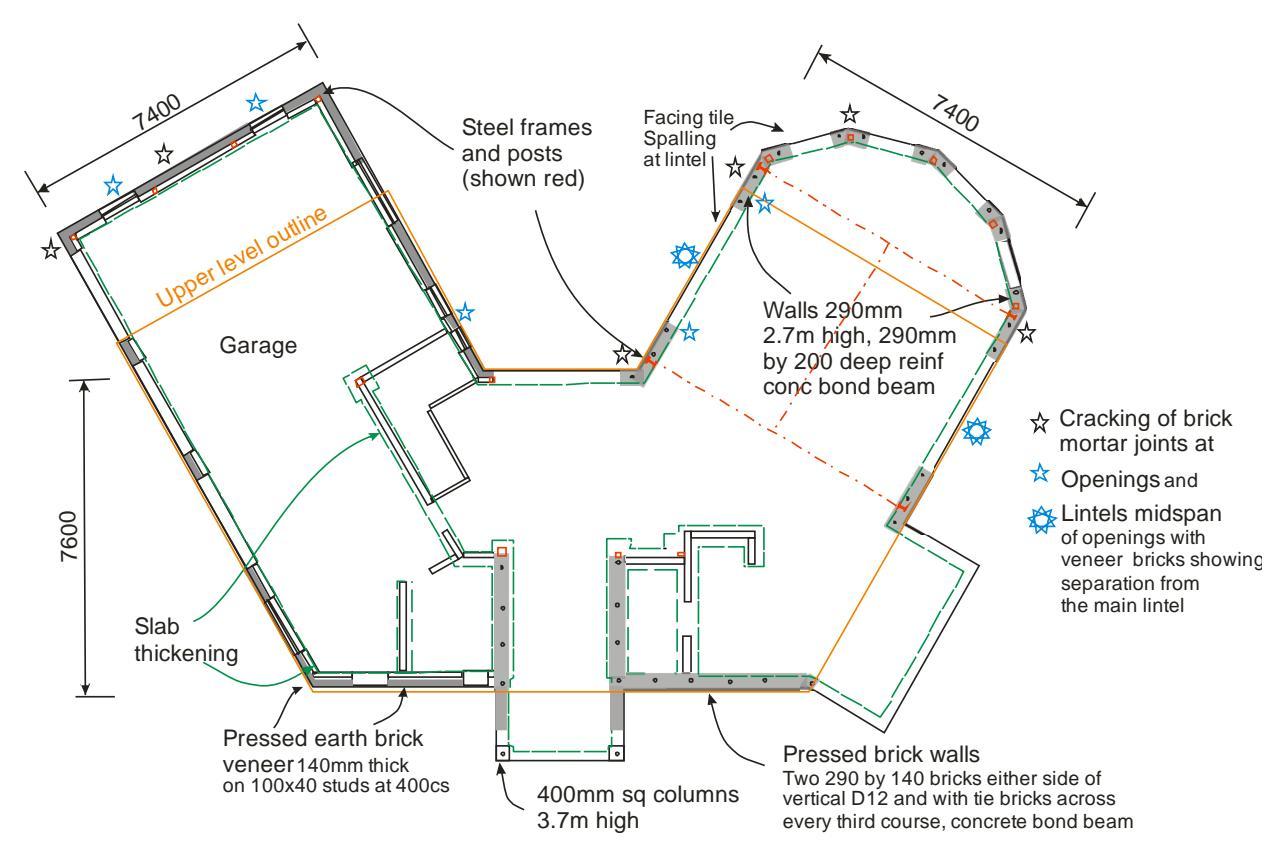
Figure 23: Little River pressed earth House 18 ground floor plan showing foundation thickening, lower level reinforced double skin and single skin veneer walls. Upper level outline shown orange.

The Little River pressed earth brick house shown in Figures 23-25 had double skin reinforced pressed brick lower storey and performed well under the moderate shaking and significant lateral seismic loads generated by the large second floor and roof and large span beams, and was basically in good shape. Most cracking was reported to have been initiated in the September 2010 earthquake or earlier. No vertical control joints provided for the pressed brick walls, if these were provided there may have been less cracking.

Figures 26 and 27 show the types of cracking adjacent to openings at the locations highlighted in Figure 23.

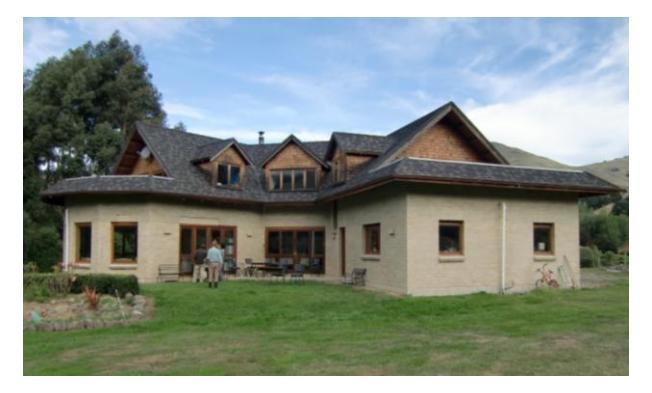
There was no damage to the foundations or to the upper level, the west side of house had 100 by 40 mm studs at 400 mm crs with 140 mm thick pressed brick veneer.

Figure 24: Little River pressed earth house 18 overview of north facing walls.
